NACCAI Stormwater Management Action Report to Mid Coast Council. Review 2 *24 Feb. 2022.

A report by the Residents Association's Roads, Drainage and Signage Sub Committee on the status of progress in completing works identified in the BMT North Arm Cove Stormwater Management Strategy Report to Council (2017), following inspections by Seamus Devlin and Gary Sylvaney during October/November 2020. For a description of priority and work level required classifications, see table on last page. It is not intended to include works requests in this report that would be considered normal periodic maintenance by the local Council Depot, for example Table Drain clearing. This Report seeks to identify for Council works planning/budgeting Stormwater/Drainage issues in North Arm Cove that create damage to residential properties, council assets, topography and/or safety hazards.

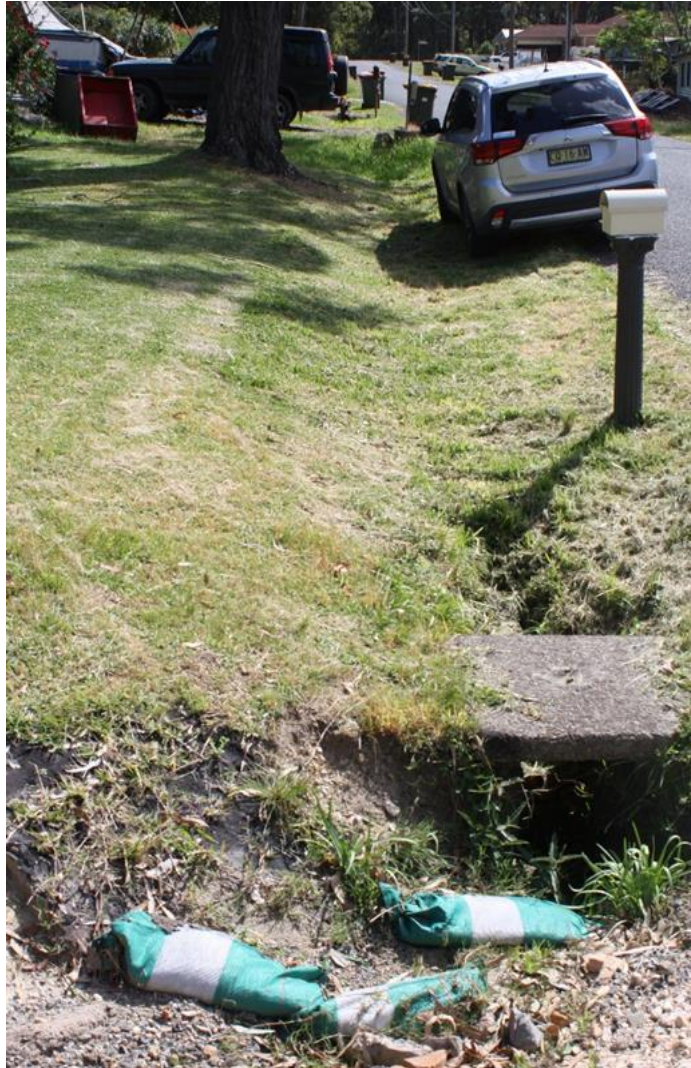
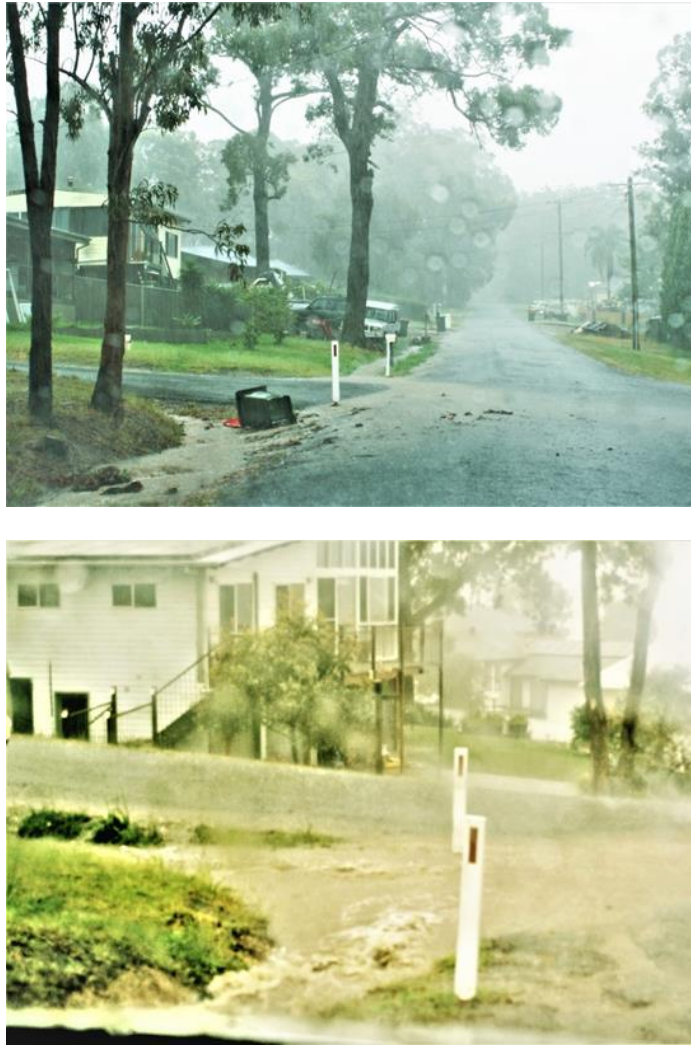
Ref. No.	BMT Map Site	Description.	Report from Observations.	Priority.	MCC Work	MCC Capital Funding & Period
3.	S1	<p>Reconstruct existing drainage pit corner Merriwa Blvd / Eastslope Way.</p>

<p>Pit has not been upgraded to mesh type and fails child safety requirements.</p> <p>Higher volumes of water being directed to it than its design can cope with and sandbags further reducing volumes.</p> <p>Pit discharges to opposite corner via under road culvert. Hazardous situation with open drain. Refer Ref. No.</p>	A	2

<p>South side Table Drain in Merriwa Blvd. west remains shallow. North side drain is now a good size.</p> <p>West side Table Drain Eastslope Way from this corner north is too shallow or absent.</p>	A		
4	S1	Construct new Debris Barriers for North side Table Drain Merriwa Blvd. to Eastslope Way.	<p>Temporary sandbags to reduce flow rate washed down drains to pit where they further reduce Pit flow.</p> <p>Permanent swales required.</p>	B	2

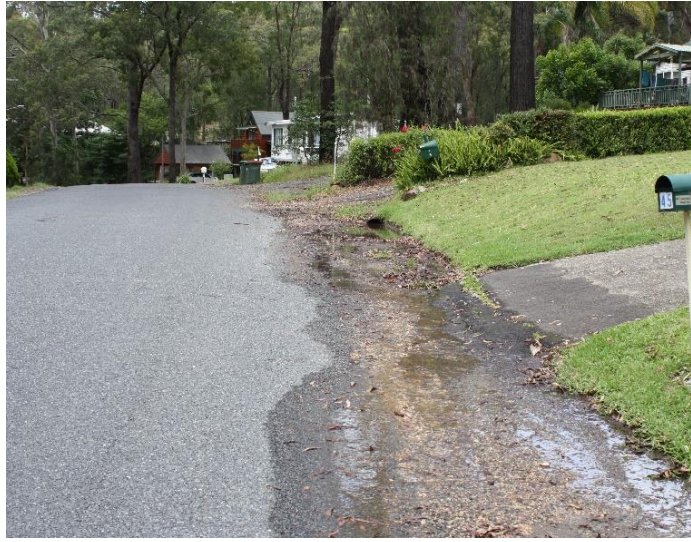
20	S2c	<p>Construct sub-soil drainage system. 43 - 49 Cove Blvd.</p>

NOT DONE.	B/C	2	
21	S2c	<p>Construct concrete dish crossing. 43 - 49 Cove Blvd.</p>	NOT DONE.	B/C	2

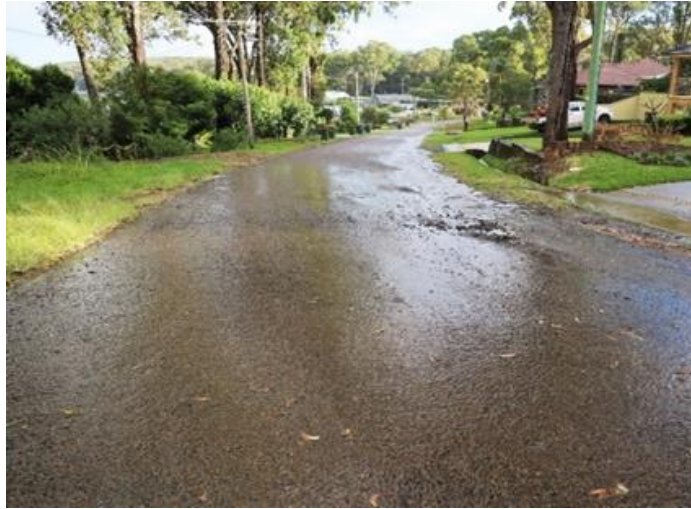
<p>91 New</p>	<p>No BMT Report. for area.</p>	<p>5 Merriwa Blvd. View south.</p>

<p>This area in the northern end of North Arm Cove was not reported as having flooding/drainage problems in the 2014 BMT Report.</p> <p>The NACCAI Stormwater and Drainage Sub Committee became aware when contacted by a resident after the draft report was placed on our web site for resident information and comment.</p> <p>Cross road flooding occurs mostly from Gloucester St. down and impacts as far as No.12.</p>			
<p>91 Cont</p>		<p>7 Merriwa Blvd. View north uphill.</p>

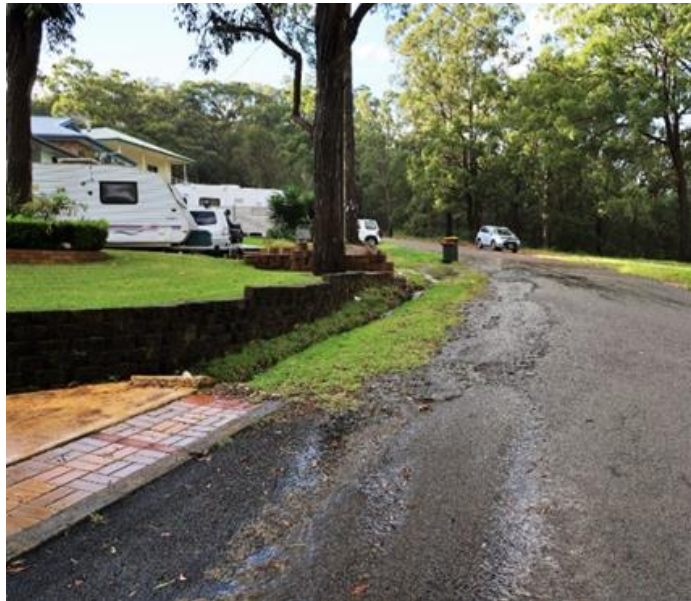
<p>A Table Drain and Driveway pipe pass some stormwater effectively downhill from this point.</p> <p>The lack of drains and under driveway pipes uphill however also sends a parallel water flow down the road and then hence to downslope properties.</p>

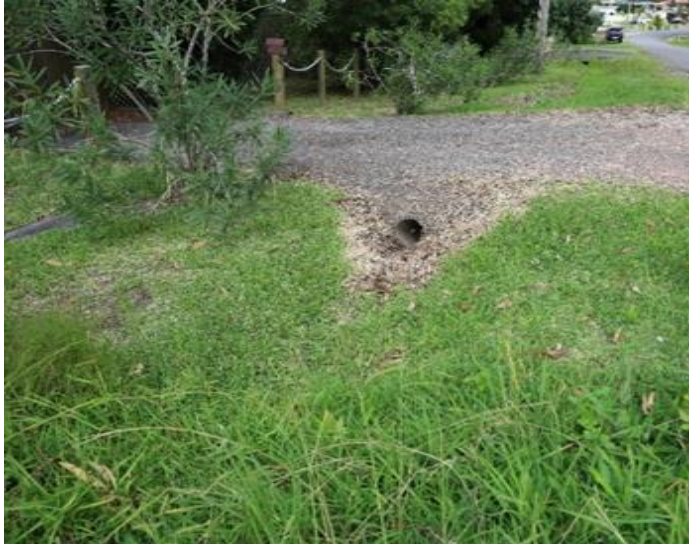
<p>91 cont</p>		<p>B). 8 Merriwa Blvd. View south.</p>

<p>B). Driveway pipe undersize at 300mm with shallow drains feeding into and from.</p>			
<p>91 cont</p>		<p>C). 8 Merriwa Blvd. View north.</p>

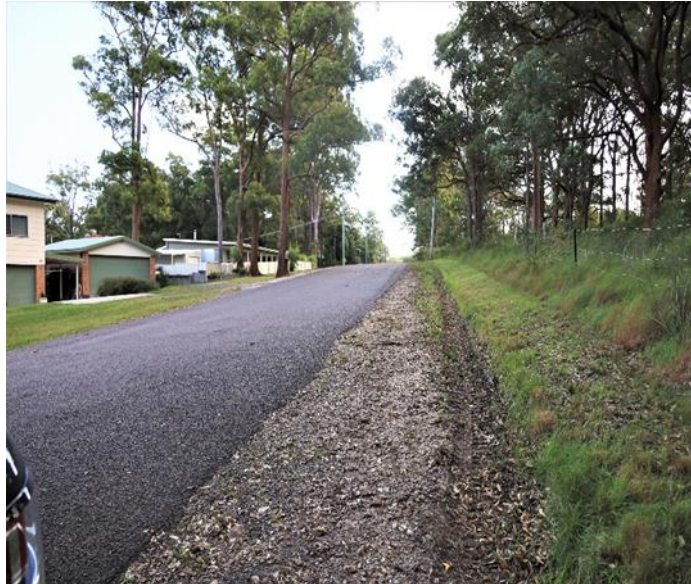
<p>Advice from long term residents is that the Surface flooding into Merriwa Blvd. is primarily coming from this area along Gloucester St. and land north and west of this intersection. Someone has recently driven the tyres of a heavy vehicle along the verge where a good size Table Drain should be. This slight indentation would have little impact on the directional control of surface flooding during heavy rains.</p>	<p>A</p>
