## **NACCAI Stormwater Management Action Report to Mid Coast Council. Review 3. 8 Nov. 2022.**

A report by the Residents Association's Roads, Drainage and Signage Sub Committee on the status of progress in completing works identified in the BMT North Arm Cove Stormwater Management Strategy Report to Council (2017), following inspections by Seamus Devlin and Gary Sylvaney during October/November 2020. For a description of priority and work level required classifications, see table on last page. It is not intended to include works requests in this report that would be considered normal periodic maintenance by the local Council Depot, for example Table Drain clearing. This Report seeks to identify for Council works planning/budgeting Stormwater/Drainage issues in North Arm Cove that create damage to residential properties, council assets, topography and/or safety hazards.

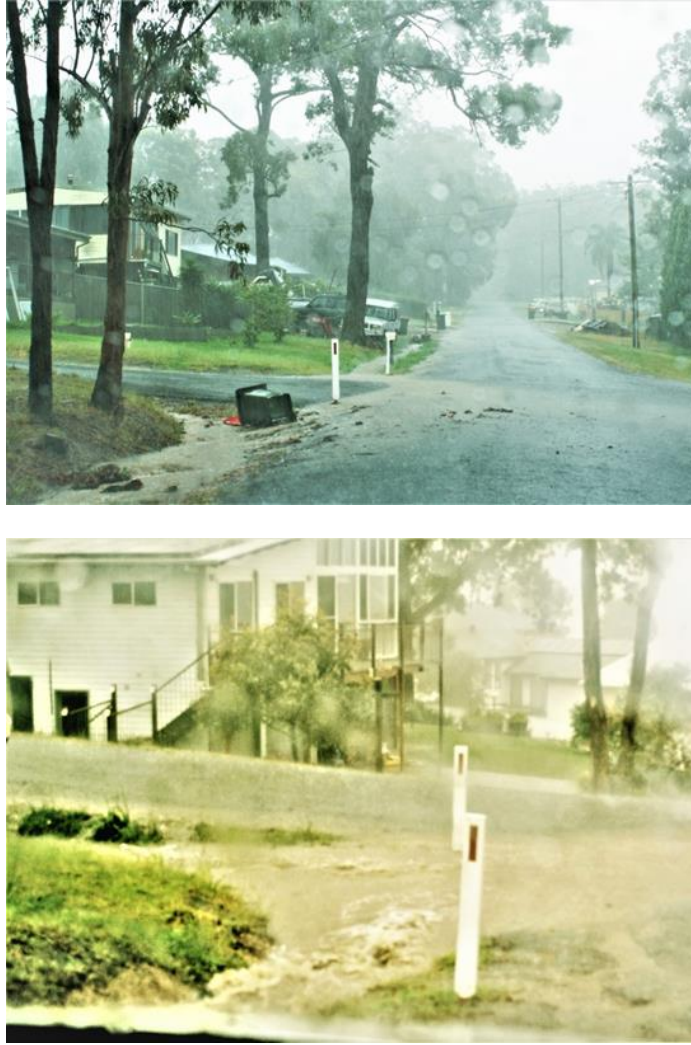
3 cont.

<p>South side Table Drain in Merriwa Blvd. west remains shallow. North side drain is now a good size.</p> <p>West side Table Drain Eastslope Way from this corner north is too shallow or absent.</p>	A		
4	S1	Construct new Debris Barriers for North side Table Drain Merriwa Blvd. to Eastslope Way.	<p>Temporary sandbags to reduce flow rate washed down drains to pit where they further reduce Pit flow.</p> <p>Permanent swales required.</p>	B	2

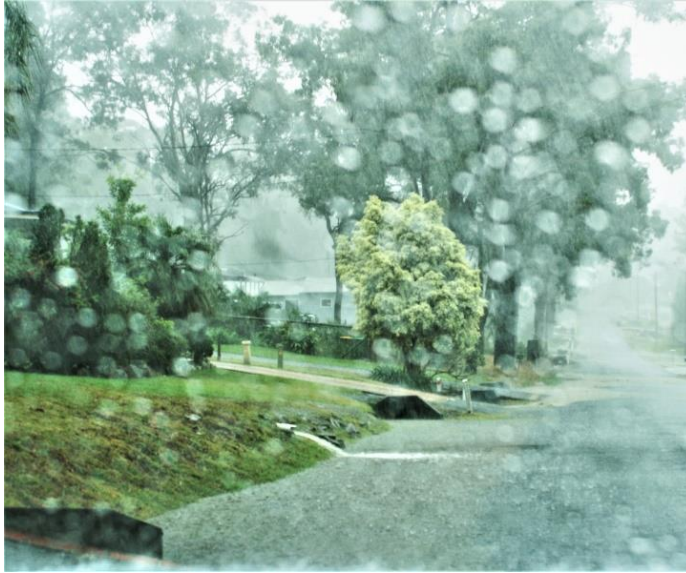
5	S1	<p>Table Drain 51 to 57 Eastslope Way.</p>

<p>Some driveway culvert improvements here. Problem is now related to table drain depth/size or absence. (Note No. 47 should read 45 in BMT Reports 2014/2017).</p> <p>If drains are rebuilt, Ref. 6 may not be required.</p> <p>Table Drains between No.51 and 57 are shallow and may not adequate for stormwater flow volumes. A Second enclosed drain however, runs below this Table Drain from property No. 51 to 61. Thence to Casuarina open outlet.</p> <p>Sustained high rainfall events have resulted in heavy cross road flooding in this area.</p>	A	1	
6	S1	<p>Construct kerb and gutter along eastern side of Eastslope Way.</p>	<p>NOT DONE. May not be required if the west side table drain is kept cleared/deepened from Merriwa Blvd. to Casuarina. Road side collection pits opposite Reserve would have sufficient capacity to handle more volume than is currently reaching them if improvements are made to these pits.</p>

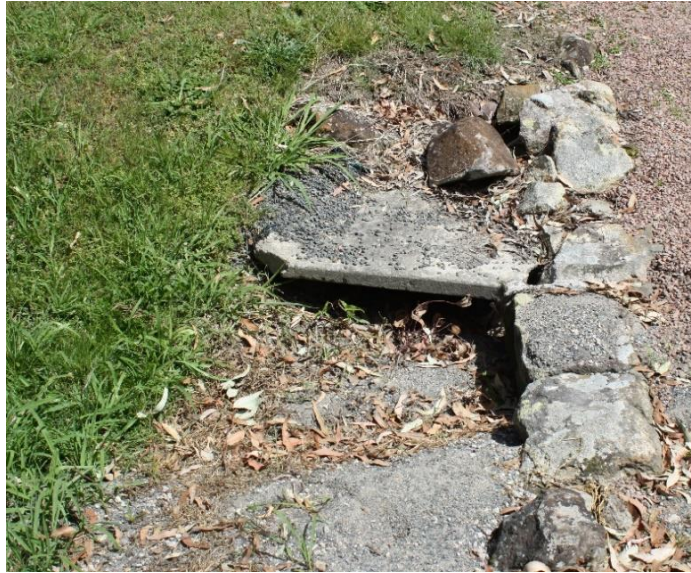
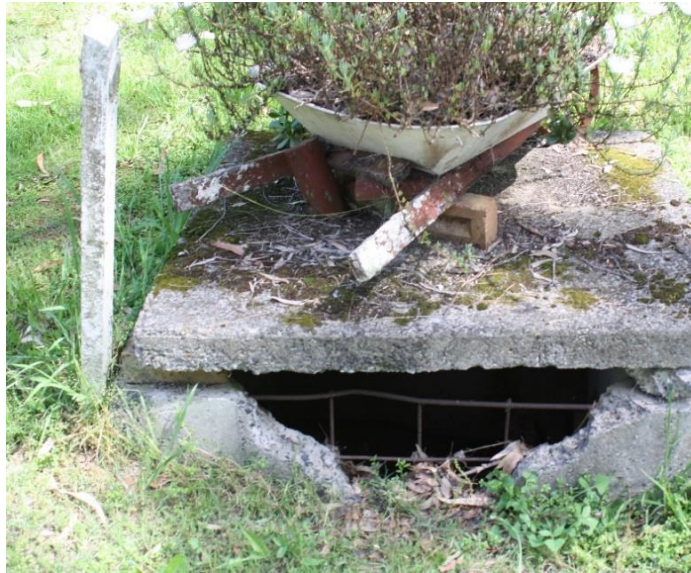
<p>8 Cont.</p>	<p>S1</p>	<p>Construct pre-treatment swale/basin and biofiltration basin in Casuarina Park.</p>

<p>NOT DONE. May not be required. North Arm Cove for historical reasons has precious little waterfront access land available for public recreation. We believe therefore any reduction in this small area is not a positive for residents. We would like to suggest an alternative.</p> <p>The drains feeding into the Casuarina Outlet (south perimeter) are more than adequate to pass any foreseeable volume of stormwater from the northern section of Eastslope Way with 2 x 760mm ID pipes as evidenced in the 2015 and 2020 storms. One west side drain centred on the park near 61 exits to the west top end of the park. It pours onto the park and Table Drain beside new sealed entry track.</p> <p>The second pit 35 metres south stays underground and empties on the east end of the park beside the Dinghy Ramp. If the first pit drain pipe was connected to the second under-ground within the park both could exit directly beside the Ramp.</p> <p>If similar swales were constructed here as were at the Water St outlet, current problems with stormwater impacting on the Ramp and therefore restrictions on its length could be resolved.</p>	<p>C</p>	<p>3</p>

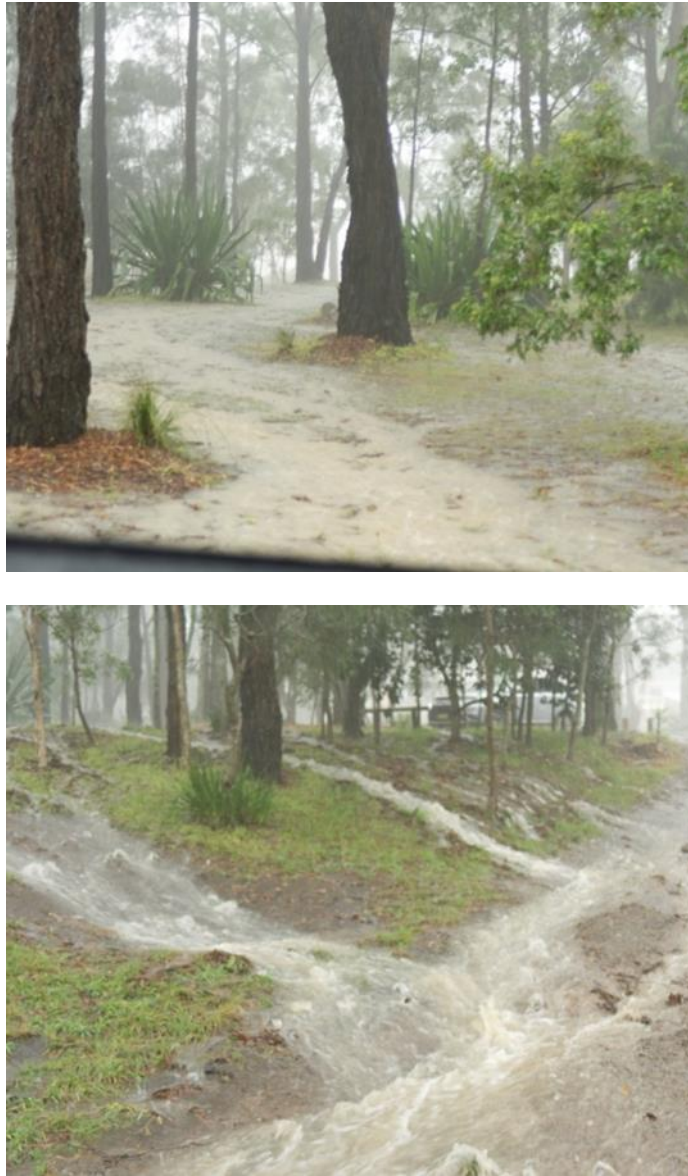
<p>8 cont.</p>	<p>S1</p>

<p>Thus, two significant problems, uncontrolled erosion of the park and inability to lengthen the Ramp to a practical and useful length would be resolved. Most importantly, the current very unsafe construction of the Ramp end would be eliminated.</p> <p>All existing Concrete pits feeding to the two main pipes including adjacent to house Nos 57, 61 and 63 should be converted to mesh style to reduce the impact of debris build-up and subsequent flow restriction.</p> <p>Currently sandbagged which ultimately further reduces the pits effectiveness.</p> <p>Heavy cross road flow into Casuarina as a consequence.</p> <p>Sealing of the track to the Ramp recently by Council has reduced the erosion flow and provided safer access. It will be interesting to record flow when the next heavy sustained rain event occurs.</p>			
--------------------	-----------	---	---	--	--	--

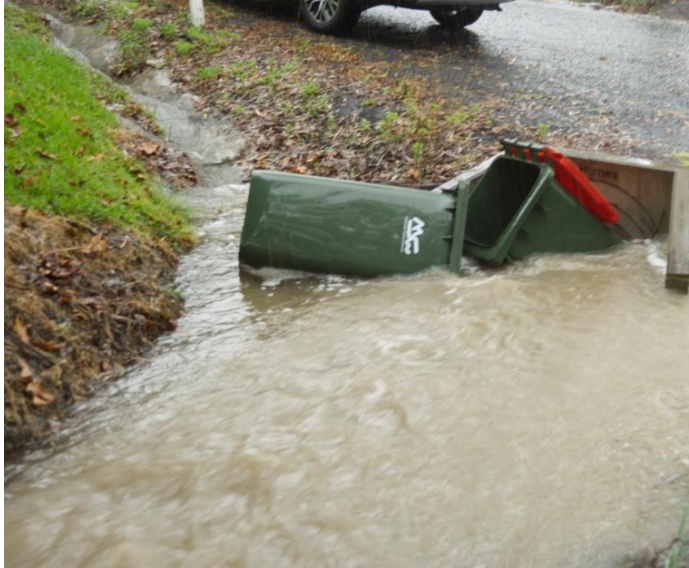
15	S2b	<p>Construct new debris barriers Water St.</p>

<p>PARTLY COMPLETED north side only.</p> <p>South side of road inlet also requires debris barriers and child access protection.</p>	A		
19	S2b	<p>Revegetation of existing informal track between Eastslope Way and The Ridgeway.</p>

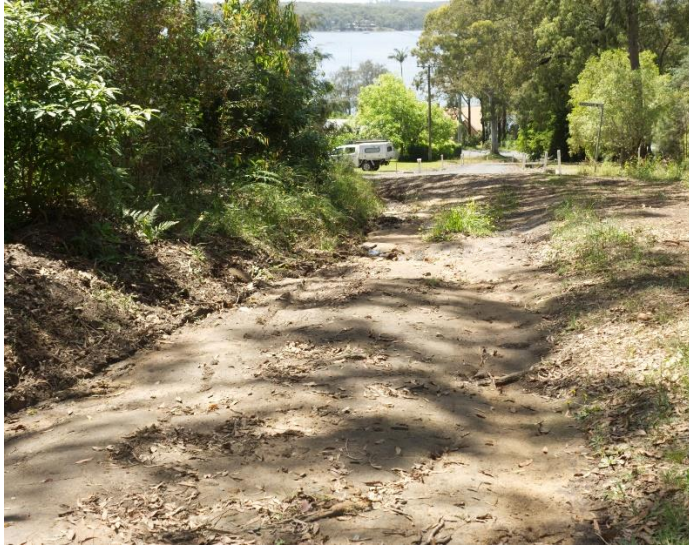
<p>NOT DONE. This is the top end of Water St. If not closed off, suggest bitumen seal and construct drains on both sides with sediment and debris diversion / barriers.</p> <p>Currently Yallarwah Park and rear access tracks to Eastslope Way homes contribute to large catchment flowing to Eastslope Way and hence to Water St. and north end Cove Blvd.</p> <p>All sources of heavy sediment transfer so require a holistic review to determine an appropriate solution.</p>	B/C	2

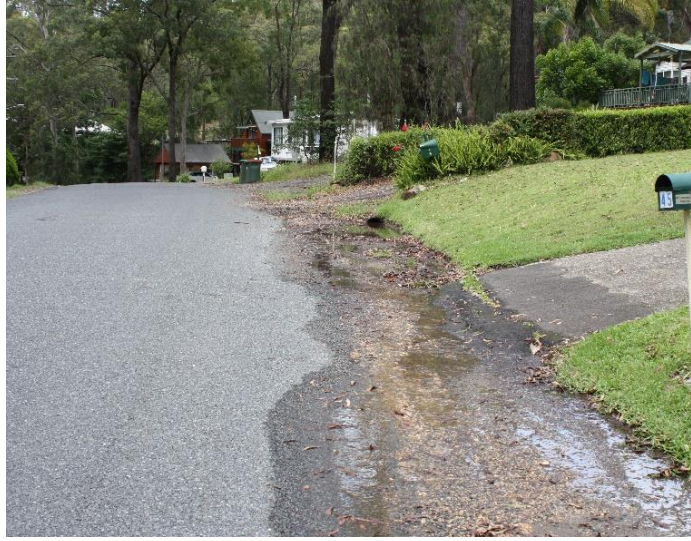
20	S2c	<p>Construct sub-soil drainage system. 43 - 49 Cove Blvd.</p>

NOT DONE.	B/C	2	
21	S2c	<p>Construct concrete dish crossing. 43 - 49 Cove Blvd. Investigate use of Table Drain and Culvert crossings.</p>	NOT DONE.	B/C	2

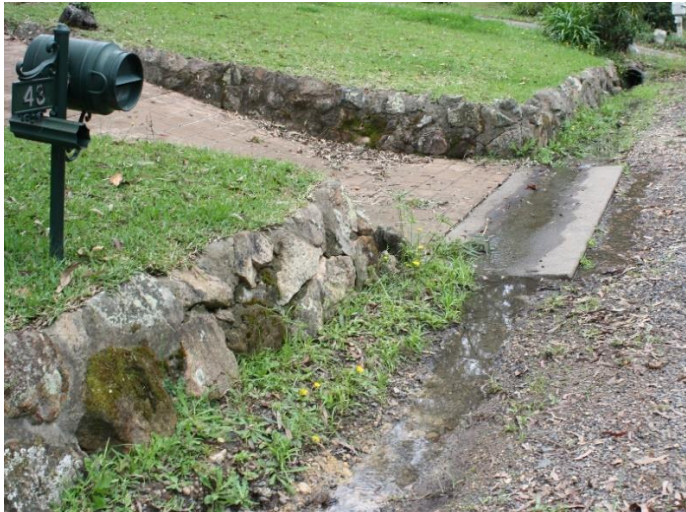
22	S2c	<p>Re-construct driveway crossings. 43 - 49 Cove Blvd.</p>

<p>NOT DONE. Currently 49 has no culvert driveway pipe. Flows from driveway cross road.</p>	B/C	2	
23	S2c	<p>Construct new kerb and gutter between 36 - 54 Cove Blvd. (east side) and adjust driveway accesses.</p>	<p>NOT DONE. Cross flow due to west side drain maintenance and sediment /gravel wash from driveways. Water flow blocked at south end of 73 Driveway pipe. Drain should be deepened.</p> <p>Gravel from driveway 51 flowing to 64 - 68.</p> <p>Kerb and gutter could wait until effect of new drain is assessed.</p>			
24	S3a Fig.4-5	<p>79 Cove Blvd. – negotiate with owner on easement.</p>	<p>Partly completed. Child access protection required for new Pit.</p>	A		
29	S3c	<p>Formalise drainage easement through 104 Cove Blvd. (Empty block).</p>	<p>Floods heavily. Block recently sold.</p>	A

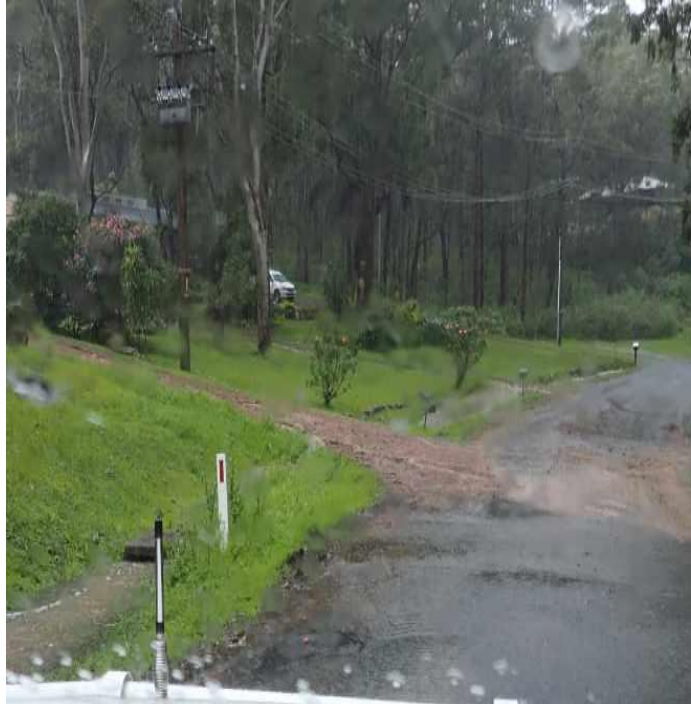
48	S5a Fig.4-8.	<p>Construct kerb and gutter in front of 91 Promontory Way and adjacent properties.</p>

<p>NOT DONE. Resident and neighbours suffer heavy flooding both around and within their dwellings from properties up slope and north / south. Besides under sized Pits, a significant problem also comes from up slope properties with unsealed driveways. Sediment and top dressing erode and washes down, blocking Culvert pipes and Table Drains (a not uncommon problem) A permanent solution for high side of the road properties with unsealed driveways and their propensity to create costs for both Neighbours and Council, would be a Council requirement they be sealed in all locations for both new and existing developments. Two of four driveways remain unsealed in this location. Resident at 91 also needs Council assistance with utilisation of a pit.</p>	A+		
----	-----------------	--	---	----	--	--

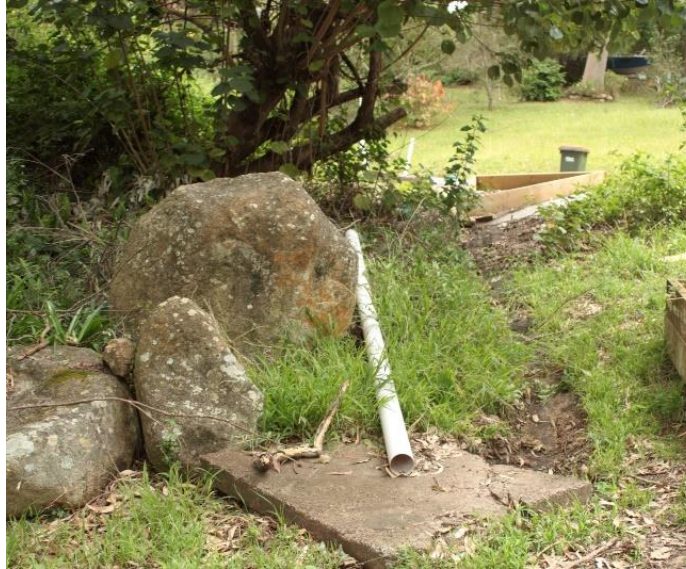
48  
Cont.

Resident needs assistance re use of pit.

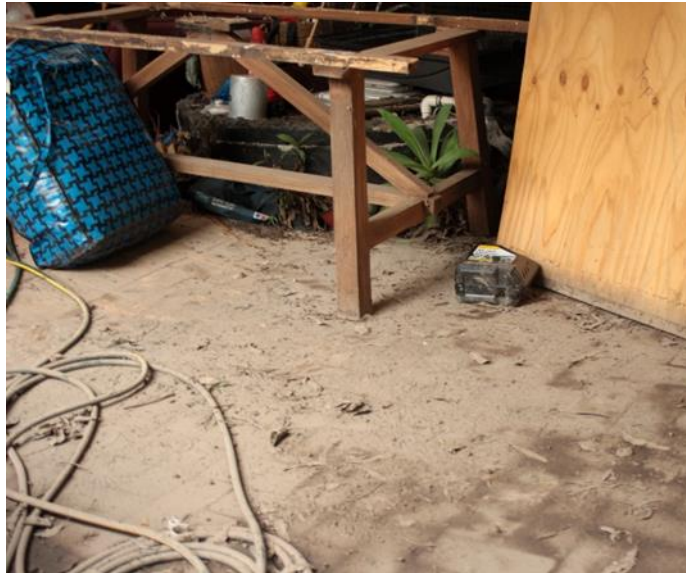
Result of flooding into garage.

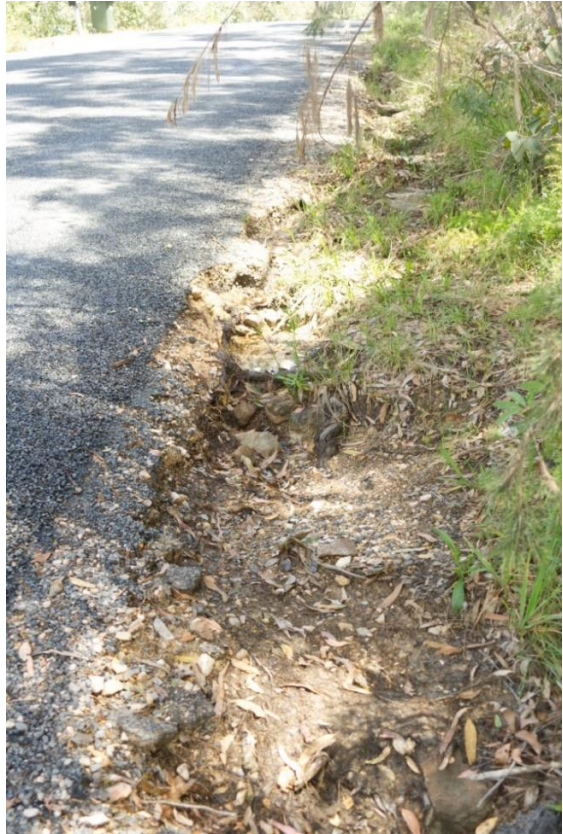
<p>Drain has eroded to edge of road bitumen.</p> <p>Requires realigning to the west to create a safe verge width.</p> <p>May require rock/boulder cutting.</p>

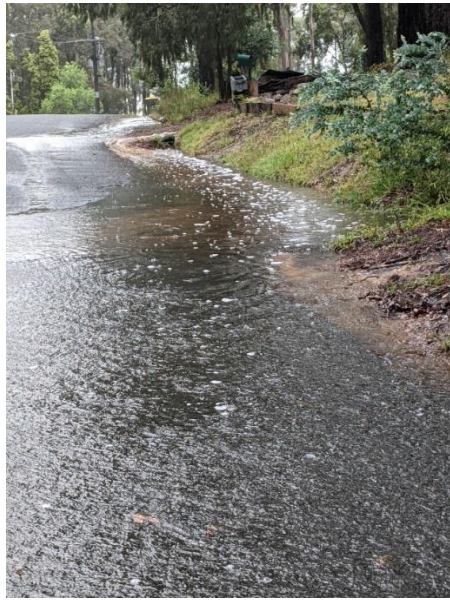
69 News	Fig 4-4 Add	35 Cove Blvd. Undersize Driveway Pipe	Below ID of up slope pipes.			
70 New	Fig 4-5 Add	35 - 41 Cove Blvd. Inadequate Table Drains.	Deepening required.			
71 News	Fig 4-4 Add	41 - 51 Cove Blvd. No Table Drains	Evidence of heavy cross road flows to 52. Heavy erosion.			
72	Fig 4-4 Add	45 - 47 Cove Blvd. Table Drain too shallow.	Deepening required.	A/B	2	
73	Fig 4-5 Add	80 Cove Blvd. Severe cross road flooding into houses.

Inadequate table drain and poorly constructed driveway opposite. 78 and 82 also affected. A causal driveway has been removed by unknow person. To be checked when heavy rain over a period occurs.			
74 New	Fig 4-6 Add	97 - 99 Cove Blvd. Pit 10 meters south has debris.	Cleaning required.	B	2	
75 New	Fig 4-6 Add	101 Cove Blvd. Driveway pipe south entry blocked.	May need drain realignment at entry.	B	2	
76 New	NA	103 Cove Blvd. Table Drain blocked.	Half filled with sediment.	A/B	2

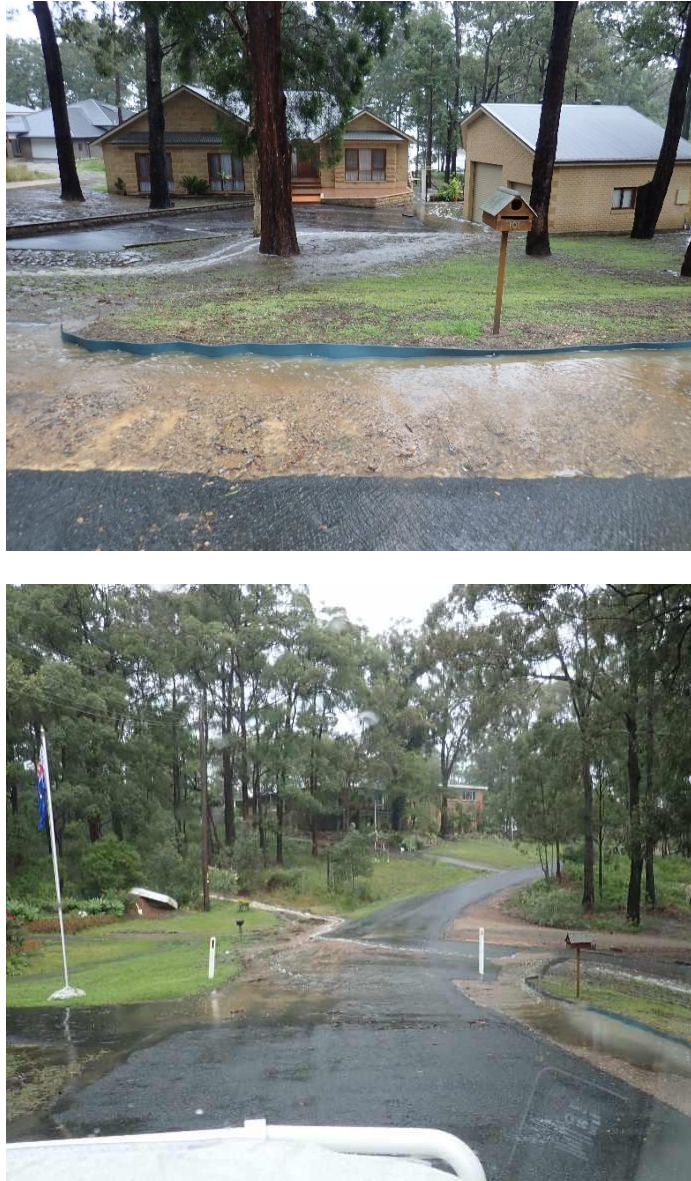
<p>85 New</p>	<p>Fig 4-8 Add</p>	<p>46 - 54 Promontory Way. No table drains or inadequate depth to handle flow volumes.</p>

<p>Area of heavy cross road flooding. Construct table drains of consistent and adequate depth. Short drain between Nos.50 - 52 but pipe openings partly blocked. No.54 needs Council works to construct a deep drain to connect with the pit in No.52.</p> <p>Suggest problem in this area should be assessed by Engineer due to complex in flows including from Outlook Drive and flooding across road into Heros via access track and into No.101.</p>	<p>A/B</p>	<p>2</p>	
-------------------	------------------------	--	--	------------	----------	--

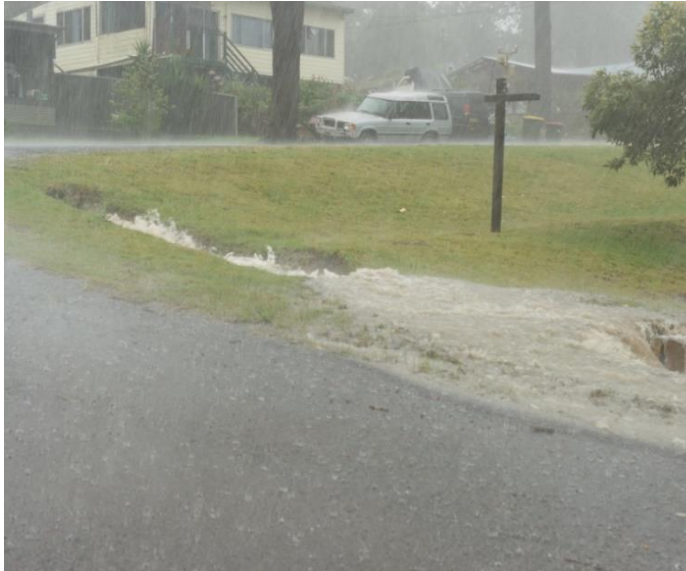
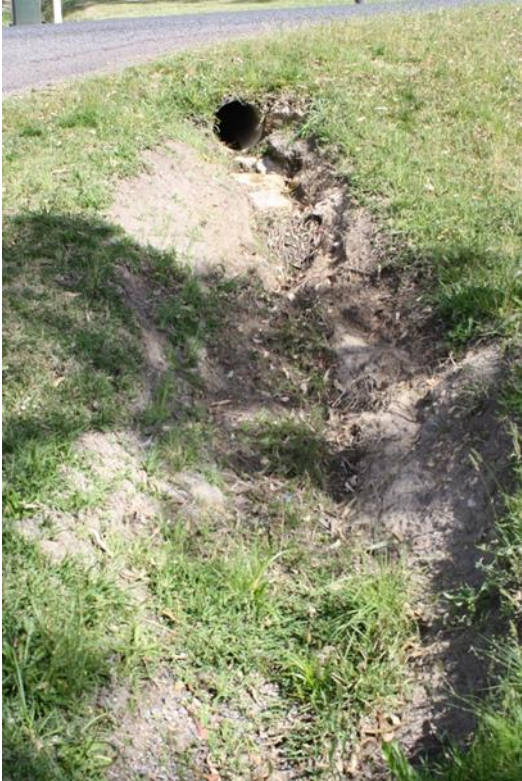
86 New	Fig 4-8	Access track to Heros Bay badly eroded on south side.	PRIORITY. Could be hazardous to vehicles and pedestrians at lower end.			
87 News	Fig 4-8	58 - 68 Promontory Way. Table drains too shallow or non-existent.	Table drains require deepening and some driveway pipes are undersize.	A/B	3	
88 New	Fig 4-8	1 - block 29 The Esplanade. (Continuation from end of Promontory Way) No table drains.	Construct Table Drains.	A/B	2	
89	Fig 4-3	<p>38 Eastslope Way. Open drain too deep.</p>

<p>Construct enclosed drain from under road outlet to driveway inlet. Currently hazardous.</p>

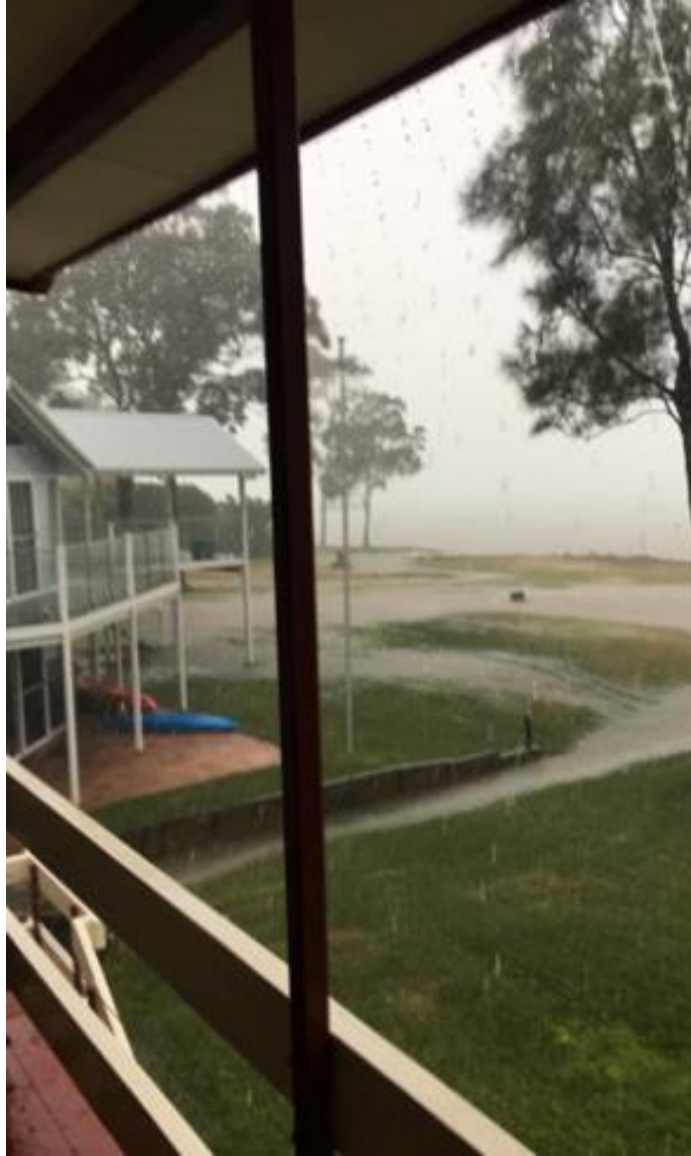
<p>90 New</p>	<p>Fig S3c</p>	<p>106 Cove Blvd. (Photo taken from 108).</p>

<p>Result of Cross Road Flooding. from uphill/upslope into Nos.104 to 106.</p> <p>104 Cove Blvd. was identified for remedial works in the 2014 BMT Report. (Refer Ref. Nos. 29-38).</p> <p>Whilst some Pit and easement work was completed just south of this location, it did not improve the Cross Road Flooding for this property.</p> <p>As recommended an additional collection pit and easement should solve the problem. The upslope flooding into this area is too excessive for existing deep Table Drains and existing Pit to cope.</p>	<p>A</p>	<p>3</p>	
-------------------	--------------------	---	---	----------	----------	--

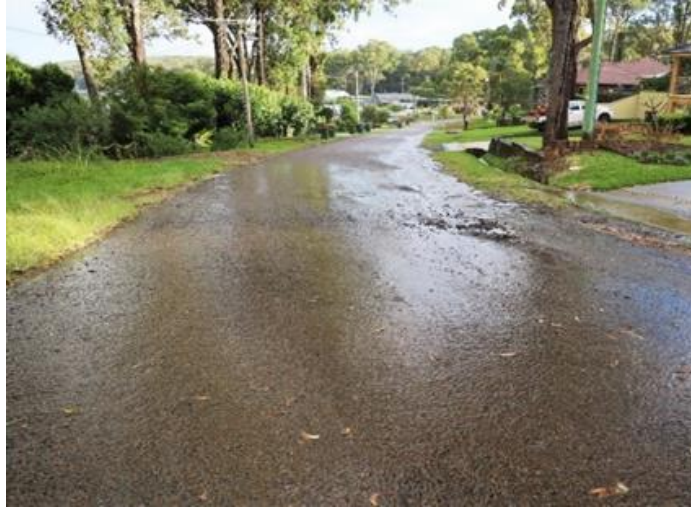
<p>91a. New</p>	<p>No BMT Report for this North end of NAC.</p>	<p>5 Merriwa Blvd. View south.</p>

<p>This area in the northern end of North Arm Cove was not reported as having flooding/drainage problems in the 2014 BMT Report.</p> <p>The NACCAI Stormwater and Drainage Sub Committee became aware when contacted by a resident after the draft report was placed on our web site for resident information and comment.</p> <p>Cross road flooding occurs mostly from Gloucester St. down and impacts as far as No.12.</p>			
<p>91b. Cont.</p>		<p>7 Merriwa Blvd. View north uphill.</p>

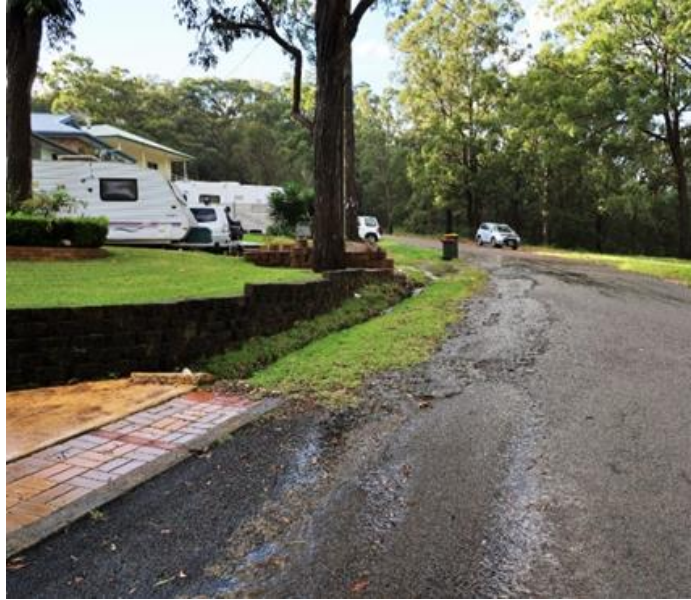
<p>A Table Drain and Driveway pipe pass some stormwater effectively downhill from this point.</p> <p>The lack of drains and under driveway pipes uphill however also sends a parallel water flow down the road and then hence to downslope properties.</p>

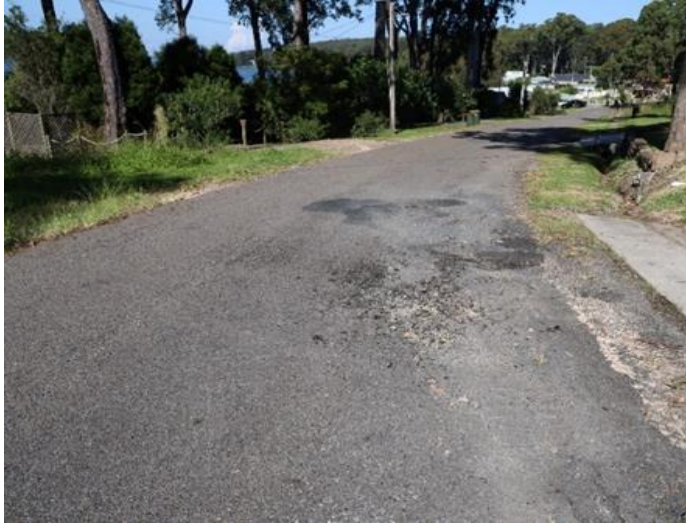
<p>91c. Cont.</p>		<p>5 Merriwa Blvd. View south downhill.</p>

<p>Road surface repaired previously showing subsequent and continuing damage in two places from heavy Cross Road Flooding from two Dish Driveways.</p>			
<p>91d. Cont.</p>		<p>A). 4 Merriwa Blvd. View north</p>

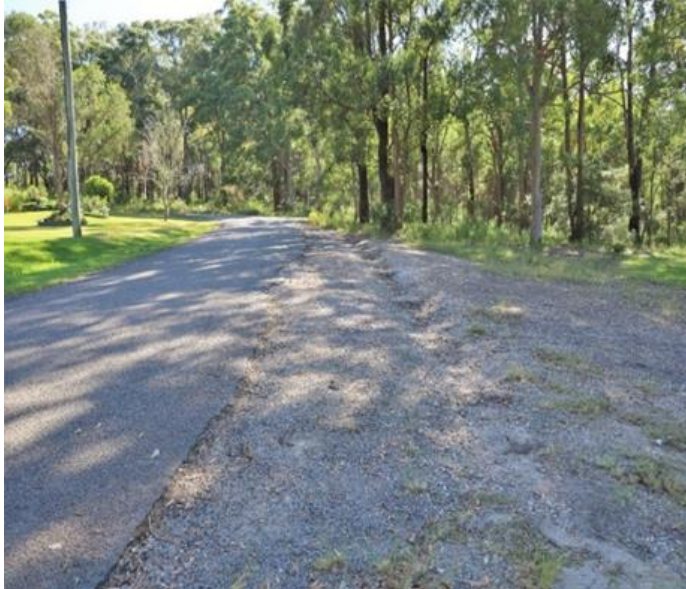
<p>A). East side of road showing edge erosion and shallow depth of drain These, with slope and lack of vegetation, creates increased flow velocity to properties adjacent and further downhill. Taken 65 metres. from Gloucester St. intersection.</p>

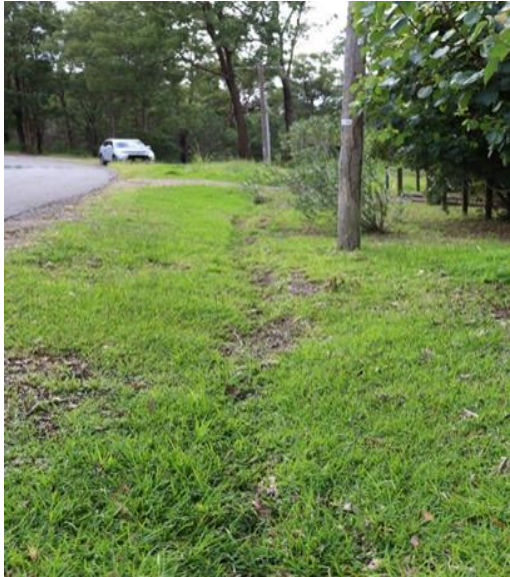
<p>91e. Cont.</p>		<p>B). 8 Merriwa Blvd. View south.</p>  	<p>B). Driveway pipe undersize at 300mm with shallow drains feeding into and from.</p>			
<p>91f. Cont.</p>		<p>C). 8 Merriwa Blvd. View north.</p>

<p>C). Shallow and poorly defined drain inadequate to control water volumes flowing from upslope and down-hill from Gloucester St.</p>

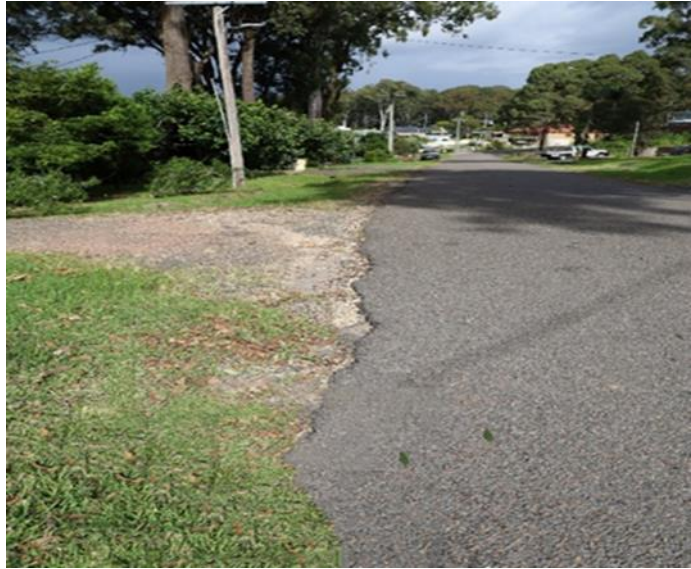
<p>91g. Cont.</p>		<p>D).8 Merriwa Blvd .View south.</p>

<p>D). Edge erosion from Cross Road Flooding.</p>			
<p>91h. Cont.</p>		<p>Corner Gloucester St. andMerriwa Blvd.. View South.</p>

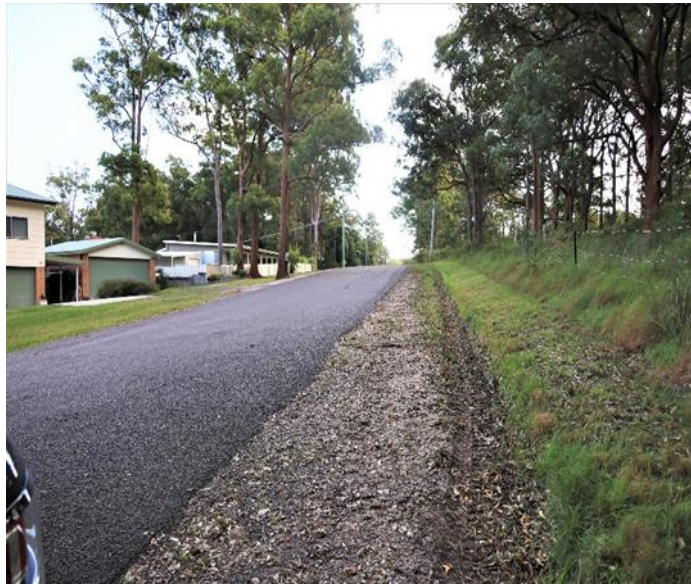
<p><b>Completed.</b></p> <p>Advice from long term residents is that the Surface flooding into Merriwa Blvd. is primarily coming from this area along Gloucester St. and land north and west of this intersection.</p> <p>Someone has recently driven the tyres of a heavy vehicle along the verge where a good size Table Drain should be. This slight indentation would have little impact on the directional control of surface flooding during heavy rains.</p>	<p>A</p>
