NACCAI Stormwater Management Action Report to Mid Coast Council. Review 3.1 9 Feb. 2023.

A report by the Residents Association's Roads, Drainage and Signage Sub Committee on the status of progress in completing works identified in the BMT North Arm Cove Stormwater Management Strategy Report to Council (2017), following inspections by Seamus Devlin and Gary Sylvaney during October/November 2020. For a description of priority and work level required classifications, see table on last page. It is not intended to include works requests in this report that would be considered normal periodic maintenance by the local Council Depot, for example Table Drain clearing. This Report seeks to identify for Council works planning/budgeting Stormwater/Drainage issues in North Arm Cove that create damage to residential properties, council assets, topography and/or safety hazards.

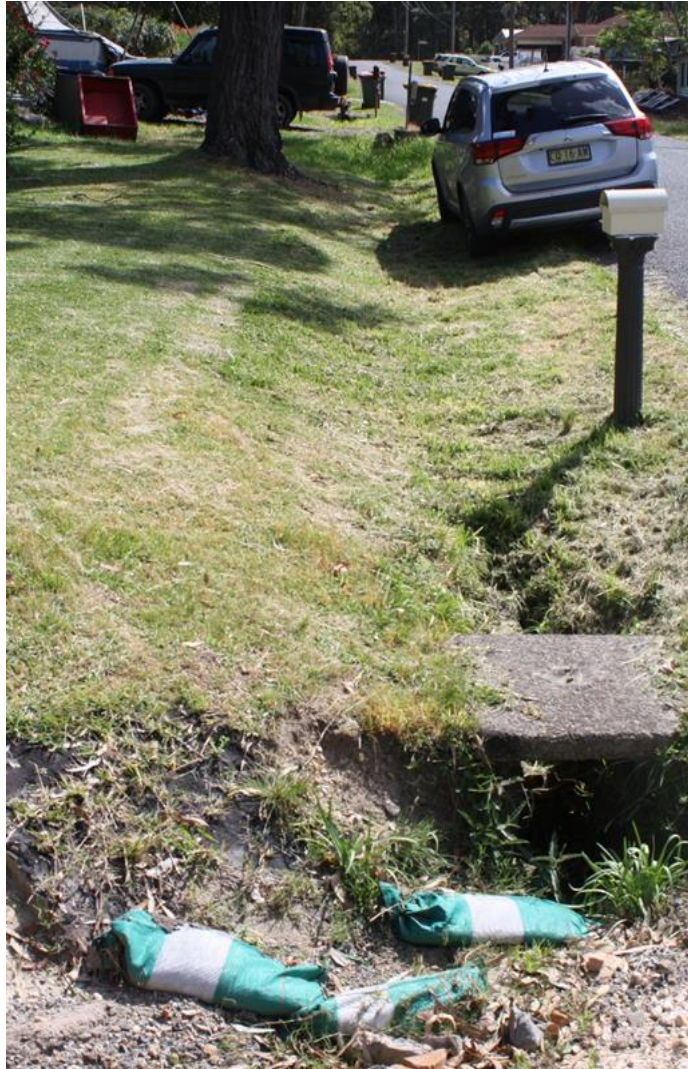
Ref. No.	BMT Map Site	Description.	Report from Observations.	Priority.	MCC Work	MCC Capital Funding & Period
3.	S1	<p>Reconstruct existing drainage pit corner Merriwa Blvd / Eastslope Way.</p>

<p>Pit has not been upgraded to mesh type and fails child safety requirements.</p> <p>Higher volumes of water being directed to it than its design can cope with and sandbags further reducing volumes.</p> <p>Pit discharges to opposite corner via under road culvert. Hazardous situation with open drain. Refer Ref. No.</p>	A	2

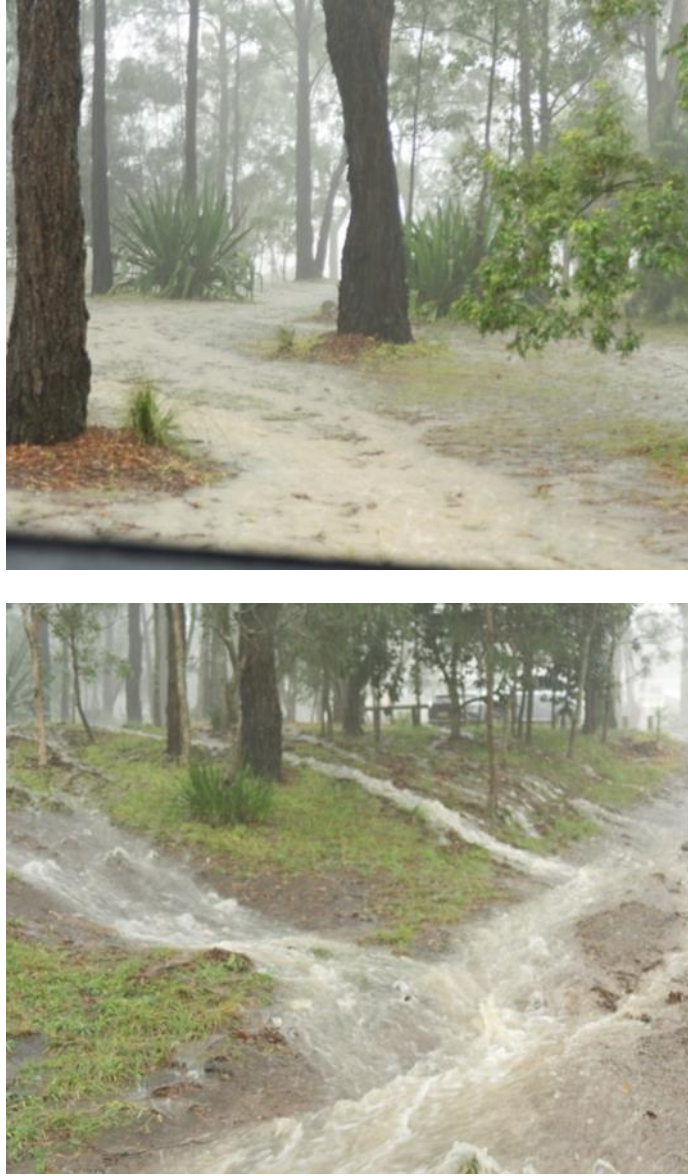
<p>8 cont.</p>	<p>S1</p>

<p>Thus, two significant problems, uncontrolled erosion of the park and inability to lengthen the Ramp to a practical and useful length would be resolved. Most importantly, the current very unsafe construction of the Ramp end would be eliminated.</p> <p>All existing Concrete pits feeding to the two main pipes including adjacent to house Nos 57, 61 and 63 should be converted to mesh style to reduce the impact of debris build-up and subsequent flow restriction.</p> <p>Currently sandbagged which ultimately further reduces the pits effectiveness.</p> <p>Heavy cross road flow into Casuarina as a consequence.</p> <p>Sealing of the track to the Ramp recently by Council has reduced the erosion flow and provided safer access. It will be interesting to record flow when the next heavy sustained rain event occurs.</p>			
--------------------	-----------	---	---	--	--	--

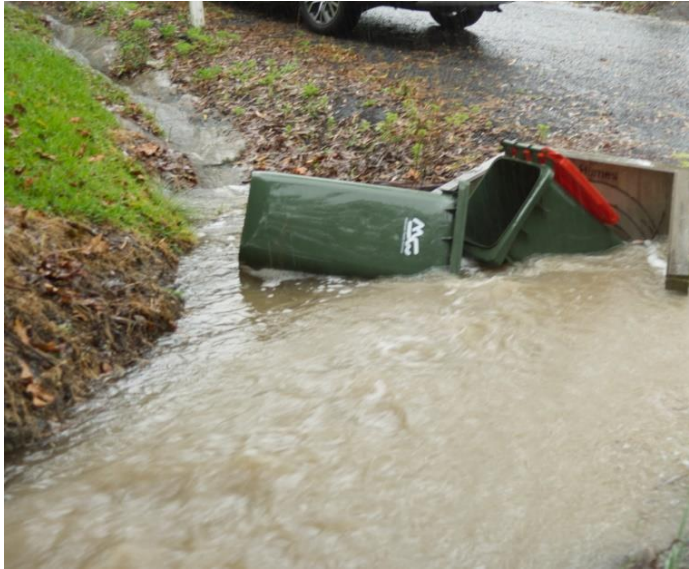
15	S2b	<p>Construct new debris barriers Water St.</p>

<p>PARTLY COMPLETED north side only.</p> <p>South side of road inlet also requires debris barriers and child access protection.</p>	A		
19	S2b	<p>Revegetation of existing informal track between Eastslope Way and The Ridgeway.</p>

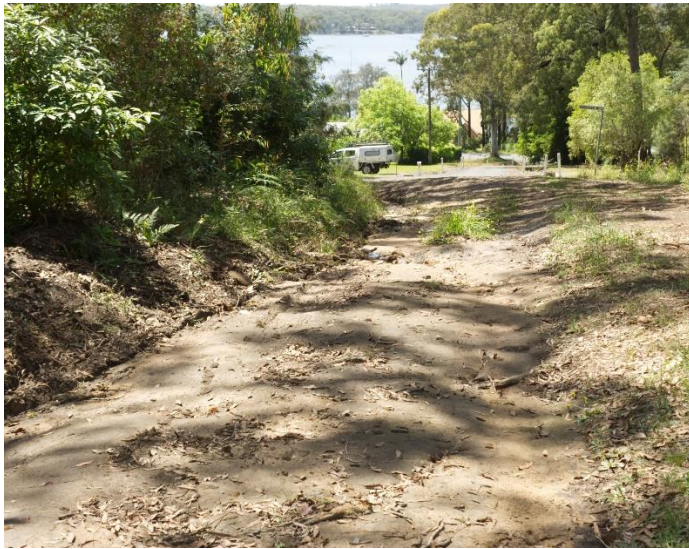
<p>NOT DONE. This is the top end of Water St. If not closed off, suggest bitumen seal and construct drains on both sides with sediment and debris diversion / barriers.</p> <p>Currently Yallarwah Park and rear access tracks to Eastslope Way homes contribute to large catchment flowing to Eastslope Way and hence to Water St. and north end Cove Blvd.</p> <p>All sources of heavy sediment transfer so require a holistic review to determine an appropriate solution.</p>	B/C	2

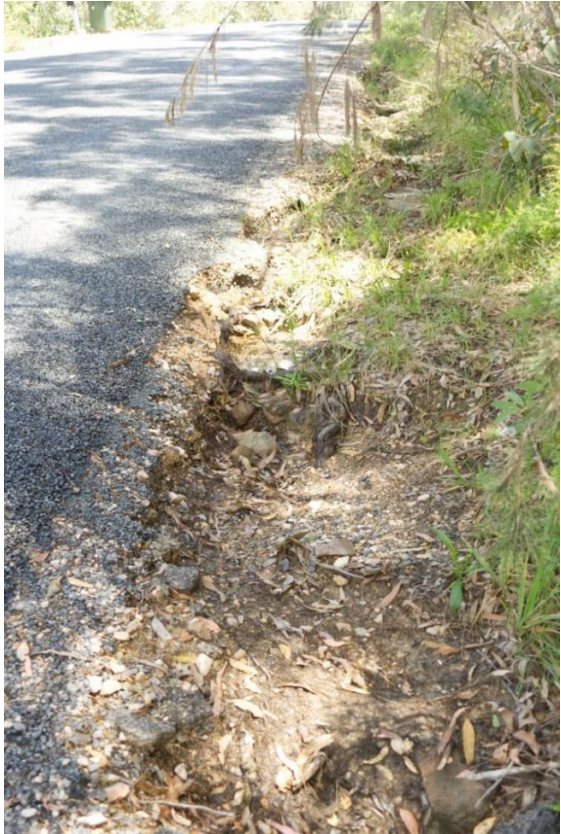
67 New	Fig.4-4 Add	Two safety posts missing from south side table drain Water St.	<p>Replace white safety posts. Whilst essential for water flow in the absence of covered pipes, the depth of drains on both sides of road require clear warnings of the steep drop off from the road edge.</p> <p>Suggest a simple safety barrier of some description be erected between driveway crossings to reduce risk to pedestrians and vehicles.</p>			
68 New	Fig 4-5 Add	<p>Table Drain 99 - 107 Cove Blvd.</p>

<p>Drain has eroded to edge of road bitumen.</p> <p>Requires realigning to the west to create a safe verge width.</p> <p>May require rock/boulder cutting.</p>

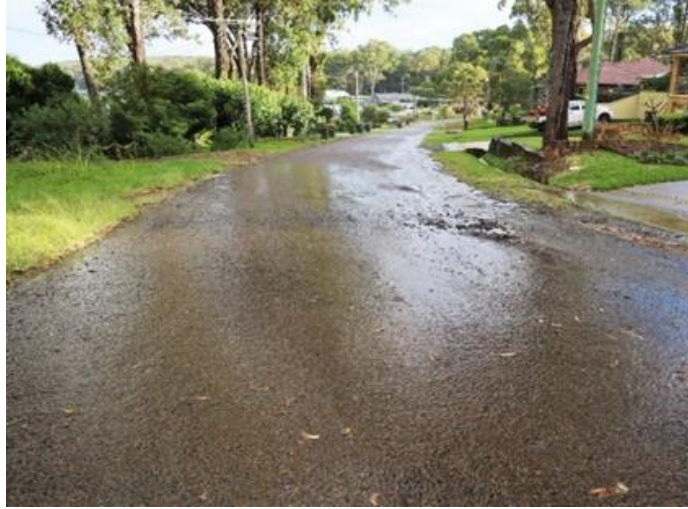
<p>91a. New</p>	<p>No BMT Report for this North end of NAC.</p>	<p>5 Merriwa Blvd. View south.</p>

<p>This area in the northern end of North Arm Cove was not reported as having flooding/drainage problems in the 2014 BMT Report.</p> <p>The NACCAI Stormwater and Drainage Sub Committee became aware when contacted by a resident after the draft report was placed on our web site for resident information and comment.</p> <p>Cross road flooding occurs mostly from Gloucester St. down and impacts as far as No.12.</p>			
<p>91b. Cont.</p>		<p>7 Merriwa Blvd. View north uphill.</p>

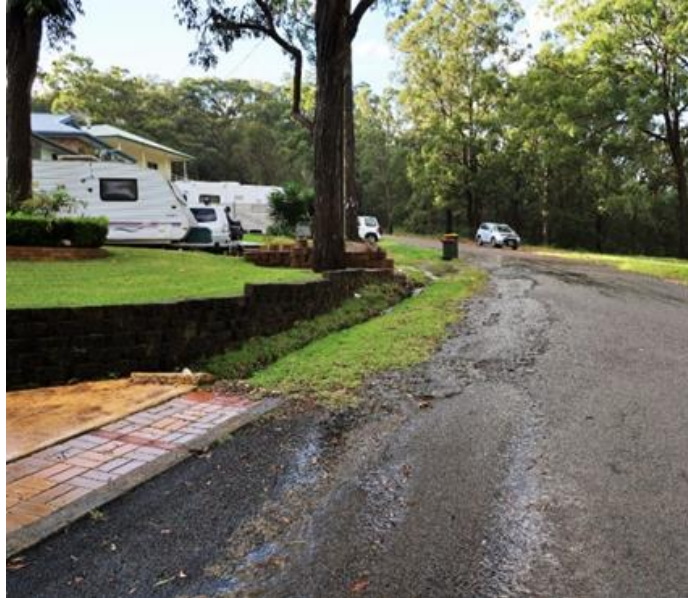
<p>A Table Drain and Driveway pipe pass some stormwater effectively downhill from this point.</p> <p>The lack of drains and under driveway pipes uphill however also sends a parallel water flow down the road and then hence to downslope properties.</p>

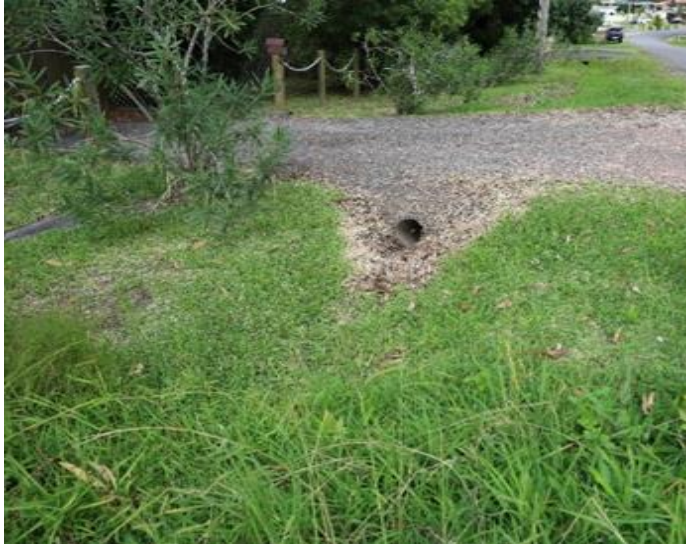
<p>91e. Cont.</p>		<p>B). 8 Merriwa Blvd. View south.</p>

<p>B). Driveway pipe undersize at 300mm with shallow drains feeding into and from.</p>			
<p>91f. Cont.</p>		<p>C). 8 Merriwa Blvd. View north.</p>

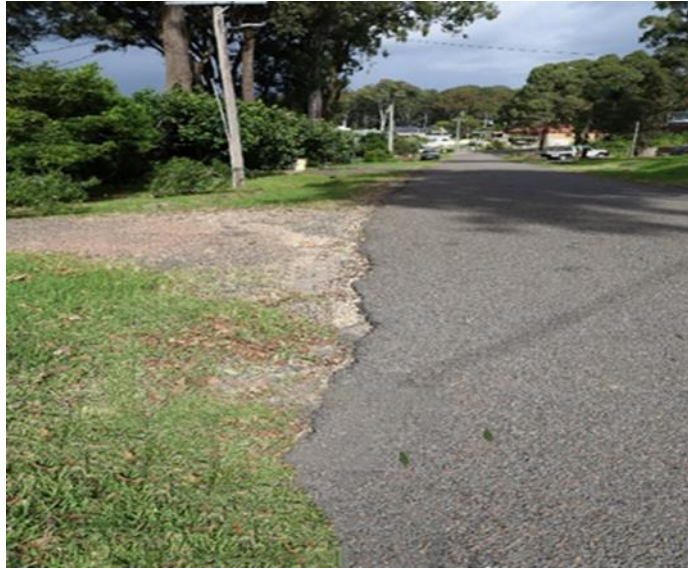
<p>91g. Cont.</p>		<p>D).8 Merriwa Blvd .View south.</p>

<p>D). Edge erosion from Cross Road Flooding.</p>			
<p>91h. Cont.</p>		<p>Corner Gloucester St. andMerriwa Blvd.. View South.</p>

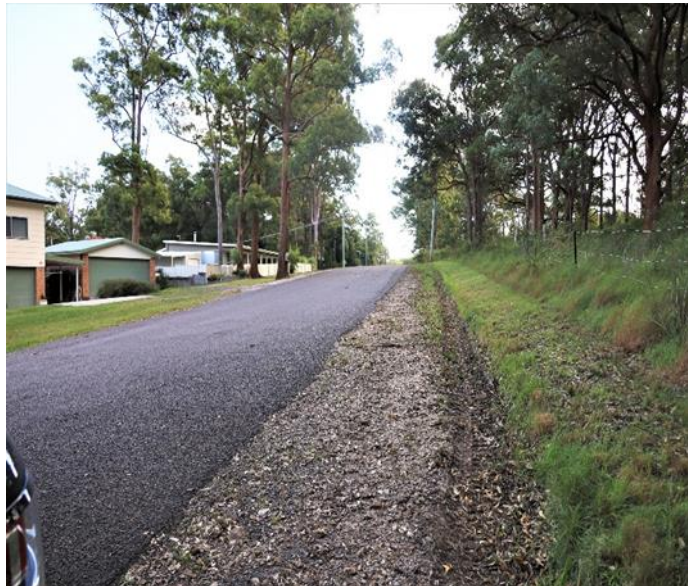
<p>Completed.</p> <p>Advice from long term residents is that the Surface flooding into Merriwa Blvd. is primarily coming from this area along Gloucester St. and land north and west of this intersection.</p> <p>Someone has recently driven the tyres of a heavy vehicle along the verge where a good size Table Drain should be. This slight indentation would have little impact on the directional control of surface flooding during heavy rains.</p>	<p>A</p>
