## Minutes for Ordinary General Meeting

### **NACCAI Stormwater Management Action Report to Mid Coast Council. Review 5. 1 Aug. 2024.**

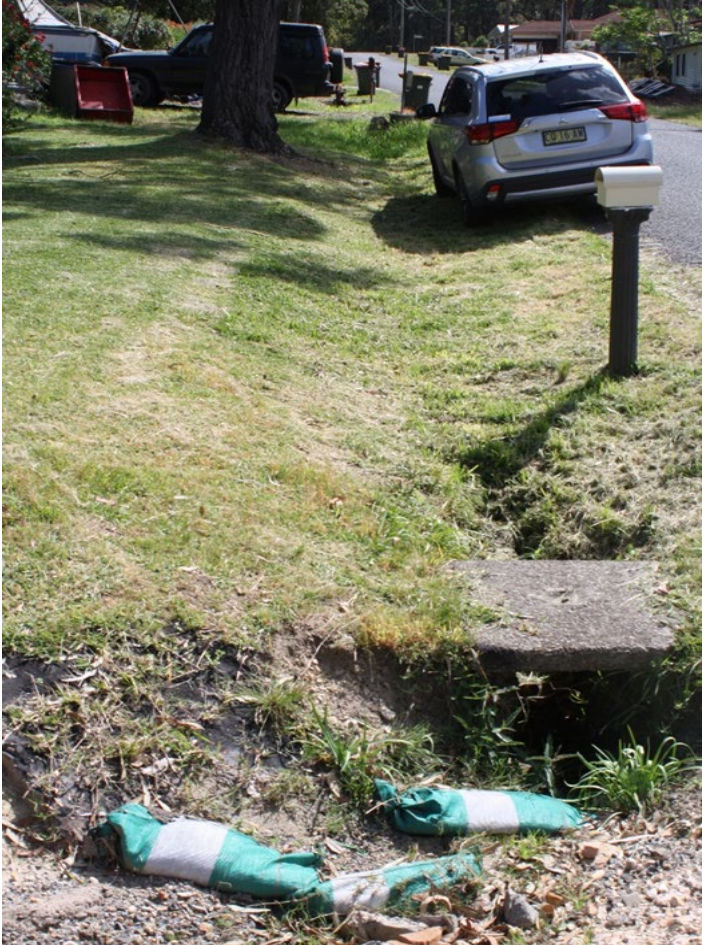
3.	S1	<p>Reconstruct existing drainage pit north west corner <u>Merriwa Blvd / Eastslope Way</u>.</p>

<p>Pit has not been upgraded to mesh type and fails child safety requirements.</p> <p>Higher volumes of water being directed to it than its design can cope with and sandbags end up further reducing water volumes due to movement to drain.</p> <p>Pit discharges to north east corner via under road culvert which is undersized for the volumes directed to it. Hazardous vehicle, pedestrian situation with open drain. Refer Ref. No.89.</p> <p>Cross road overflows from this Drain consistently damage adjacent road surfaces.</p>	A	1 & 2	
----	----	---	--	---	-------	--

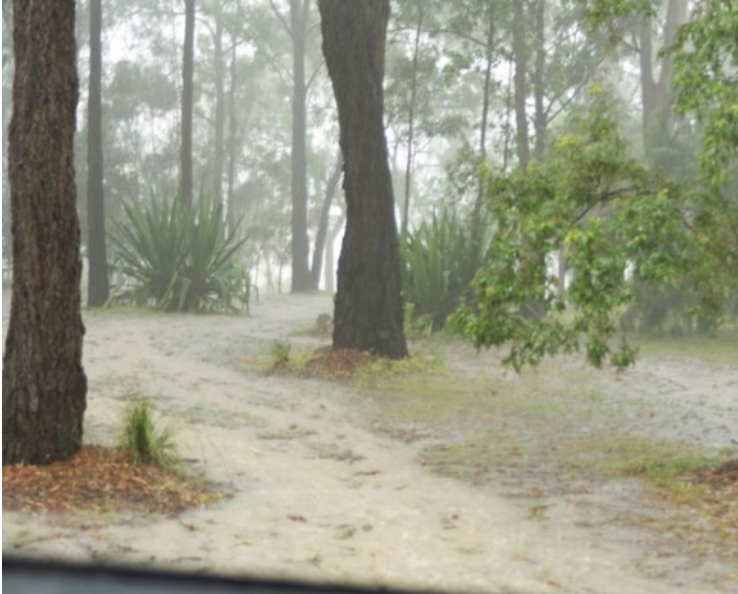
8 cont.	S1	<p><u>Casuarina Park</u></p>

<p>Thus, two significant problems, uncontrolled erosion of the park and inability to lengthen the Ramp to a practical and useful length would be resolved. Most importantly, the current very unsafe construction of the Ramp end would be eliminated.</p> <p>All existing Concrete pits feeding to the two main pipes including adjacent to house Nos 57, 61 and 63 should be converted to mesh style to reduce the impact of debris build-up and subsequent flow restriction.</p> <p>Currently sandbagged which ultimately further reduces the pits effectiveness.</p> <p>Heavy cross road flow into Casuarina as a consequence. Sealing of the track to the Ramp recently by Council has reduced the erosion flow and provided safer access. It will be interesting to record flows when the next heavy sustained rain event occurs.</p>			
------------	----	---	---	--	--	--

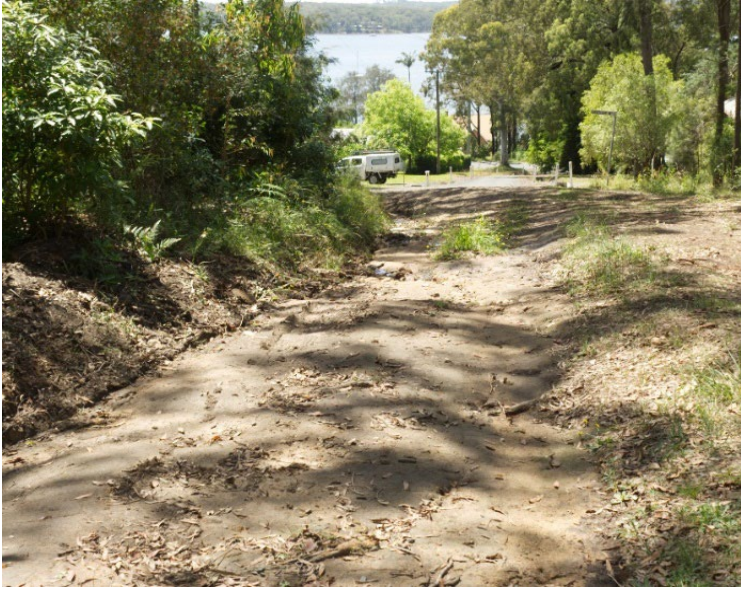
19	S2b	<p>Regrade &amp; seal track between corner <u>Eastslope Way and Water St.</u> and Yallahah Park, east side car parking area.</p>

<p>NOT DONE. This is the top end of Water St. <u>Suggest regrade and bitumen seal.</u> Construct drains on both sides with sediment and debris diversion / barriers.</p> <p>Currently vehicle access to the Park and rear of properties from here is blocked to vehicles by boulders. These should be removed now to allow access to convenient parking adjacent to the Exercise Track and clear access for Fire Tenders and Crews to this area.</p>	A+	2	
----	-----	---	--	----	---	--

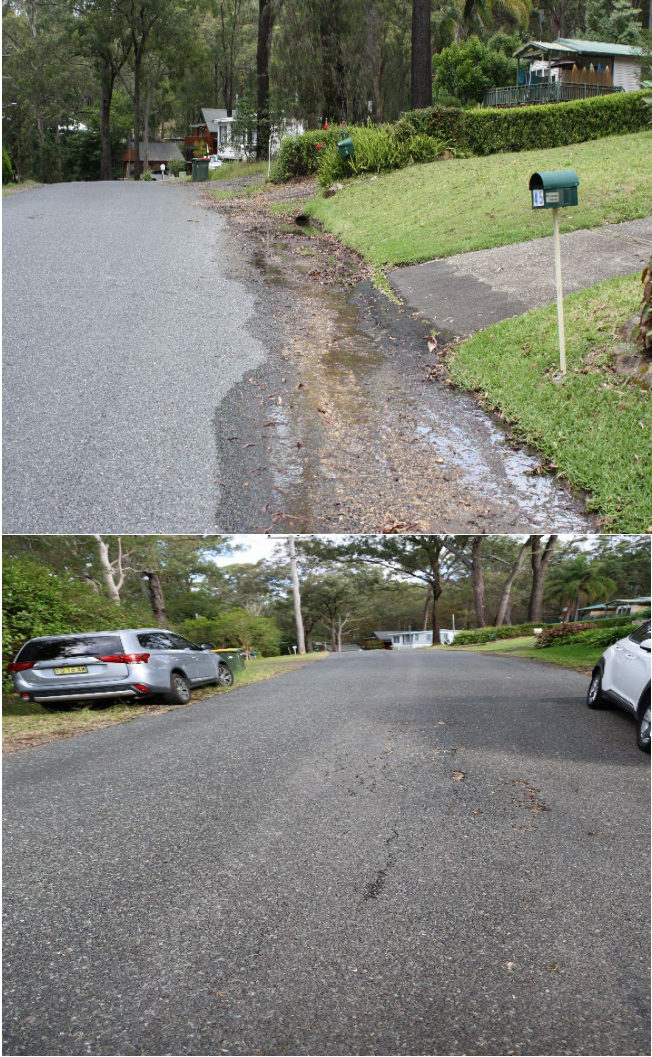
20	S2c	<p>Construct sub-soil drainage system. <u>43 - 49 Cove Blvd.</u></p>

<p>NOT DONE.</p> <p>Taken during 2024 review. Road surface damage due to heavy Cross Road flooding since 2023 Review. Previous patching evident.</p>	A	2	
----	-----	---	--	---	---	--

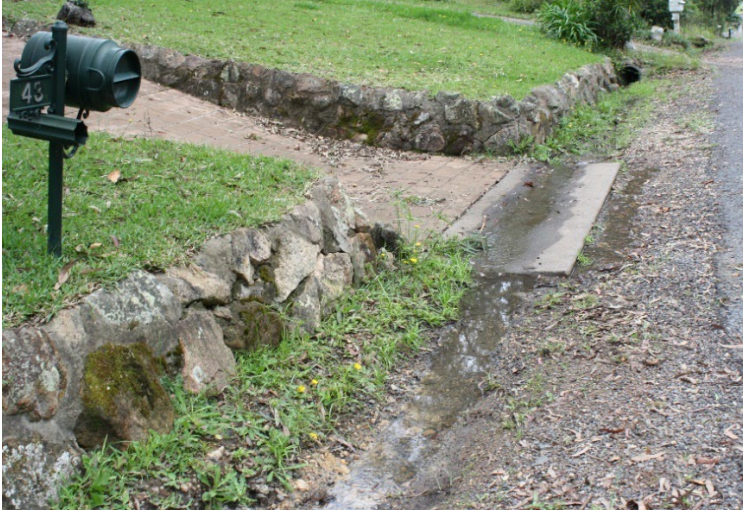
21	S2c	Construct Table Drain and Culvert Pipe Driveway crossings 43-49.	NOT DONE.	B/C	2	
22	S2c	Re-construct driveway crossings. <u>43 - 49 Cove Blvd.</u>

NOT DONE. Currently 49 has no culvert driveway pipe. Flows from driveway across road with consequent road surface damage.	A	2	
23	S2c	Construct new kerb and gutter between <u>36 - 54 Cove Blvd.</u> (east side) and adjust driveway accesses.	NOT DONE. Cross flow due to west side drain maintenance and sediment /gravel wash from driveways. Water flow blocked at south end of 73 Driveway pipe. Drain should be deepened. Gravel from driveway 51 flowing to 64 - 68.  Kerb and gutter should not be required if Table Drain and Culvert Driveways were constructed and maintained to reduce Cross Road Flooding to properties opposite.	A

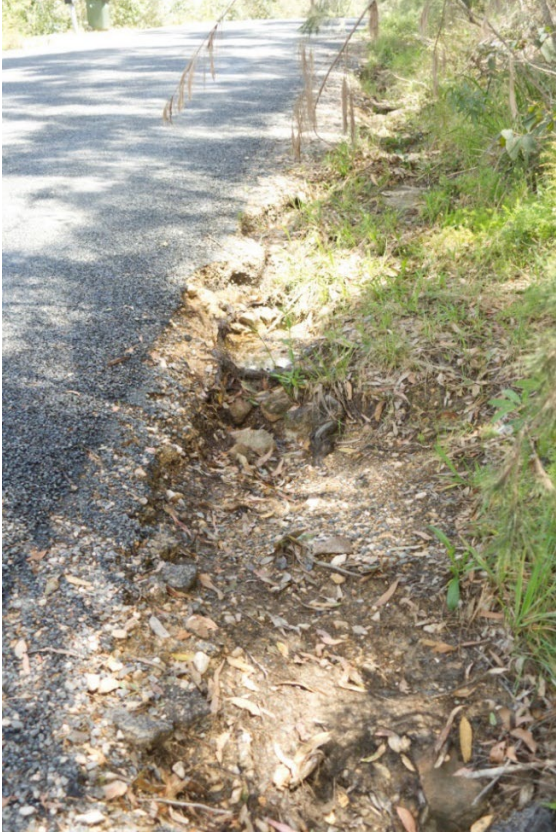
68 New	Fig 4-5	<p>Table Drain <u>99 - 107 Cove Blvd.</u></p>

<p>Drain has eroded to edge of road bitumen. Requires realigning to the west to create a safe verge width. May require rock/boulder cutting. Dangerous due to narrow road width.</p>	A		
71 New	Fig 4-4	<p><u>41 - 51 Cove Blvd.</u> No Table Drains</p>	<p>Evidence of heavy cross road flows to 52. Heavy erosion.</p>			
72 New	Fig.4-4	<p><u>45-47 Cove Blvd.</u> Table Drain too shallow.</p>	<p>Deepening required.</p>	A/B

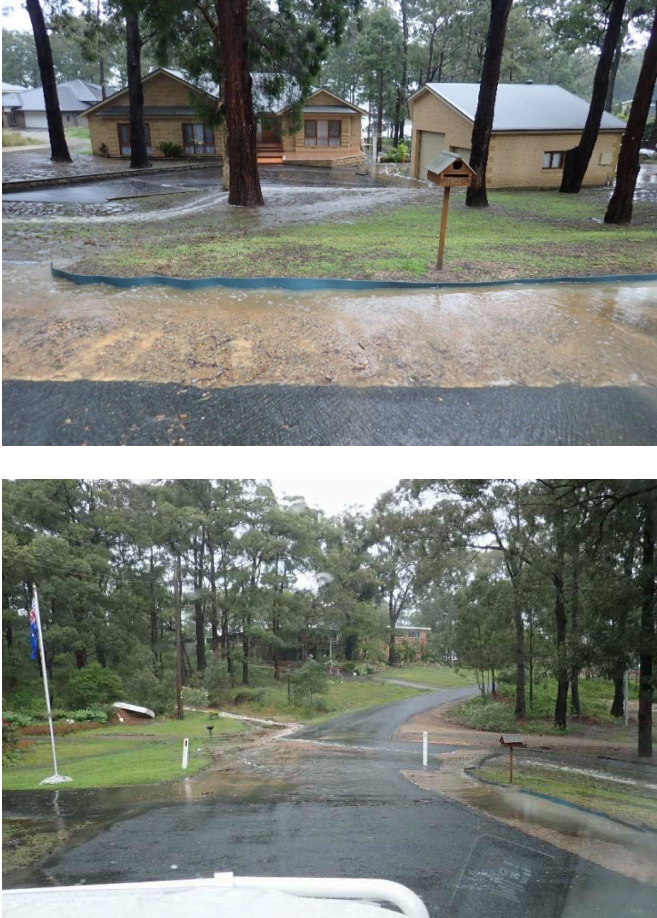
<p>85 New</p>	<p>Fig 4-8 Add</p>	<p>46 - 54 Promontory Way. No table drains or of inadequate depth to handle flow volumes.</p>

<p>Area of heavy cross road flooding. Construct table drains of consistent and adequate depth. Short drain between Nos.50 - 52 but pipe openings partly blocked. No.54 needs Council works to construct a deep drain to connect with the pit in No.52.</p> <p>Suggest problem in this area should be assessed by Engineer due to complex in flows including from Outlook Drive and flooding across road into Heros via access track and into No.101.</p>	<p>A/B</p>	<p>2</p>	
<p>86 New</p>	<p>Fig 4-8</p>	<p><u>Access road to Heros Beach.</u> South side drain deeply eroded.</p>	<p>PRIORITY. Could be hazardous to vehicles and pedestrians. Road should be sealed.</p>	<p>A</p>

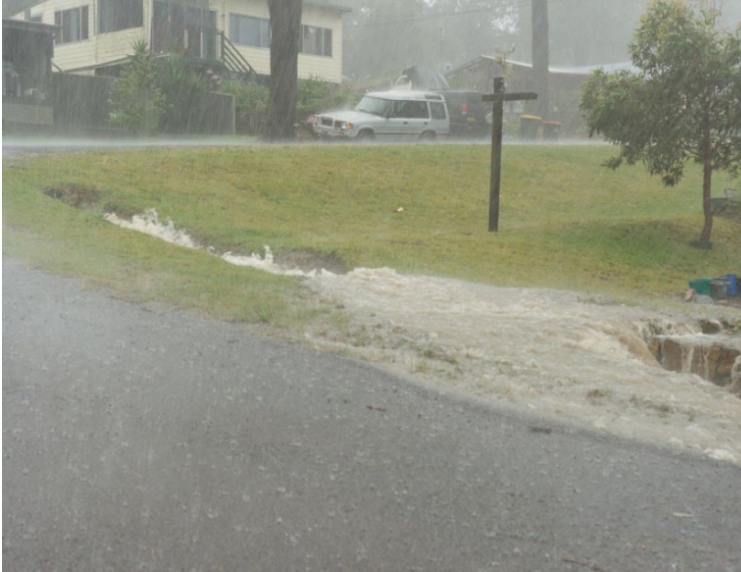
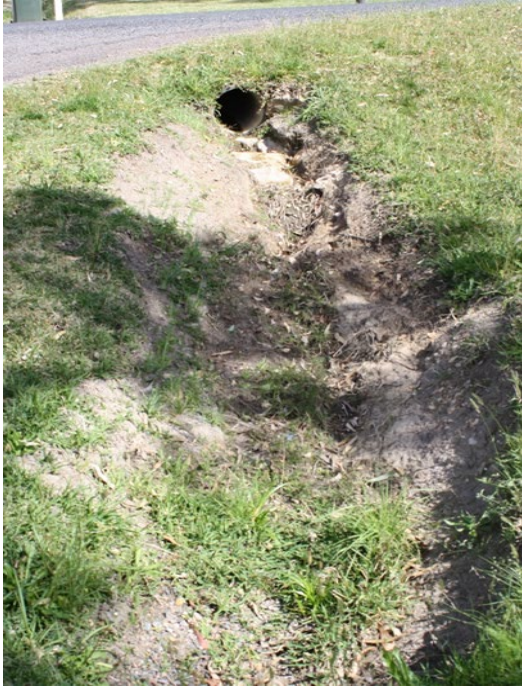
<p>89 New</p>	<p>Fig 4-3</p>	<p><u>38 Eastslope Way.</u>          Dangerous, deep Open Drain.</p>

<p>Fully enclose drain from under road outlet on Eastslope Way to driveway inlet on Merriwa Blvd. Open drain is very hazardous and has existed for a number of years. Part of drainage problem listed at Ref.3. Under road pipe should be greater diameter to reduce overflow at input Drain on opposite corner.</p>

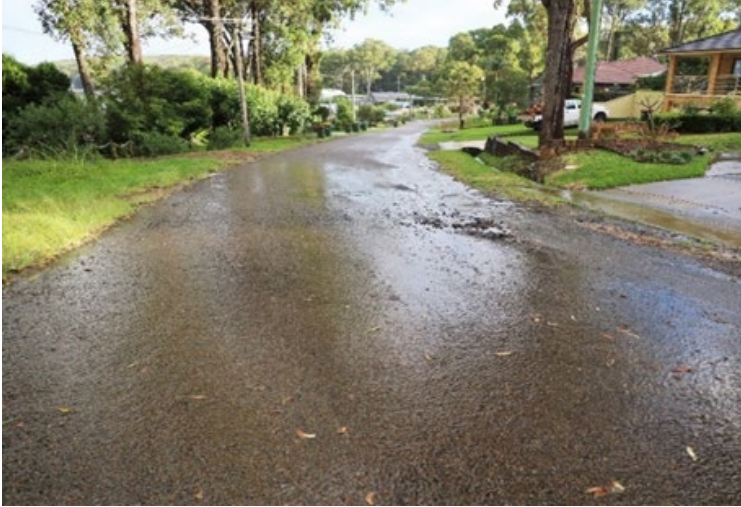
91a.	No BMT Report for this North end of NAC.	<p><u>5 Merriwa Blvd.</u> View south.</p>

<p>This area in the northern end of North Arm Cove was not reported as having flooding/drainage problems in the 2014 BMT Report.</p> <p>The NACCAI Stormwater and Drainage Sub Committee became aware when contacted by a resident after the draft report was placed on our web site for resident information and comment.</p> <p>Cross road flooding occurs mostly from Gloucester St. down and impacts as far as No.12.</p>	A		
------	--	--	---	---	--	--

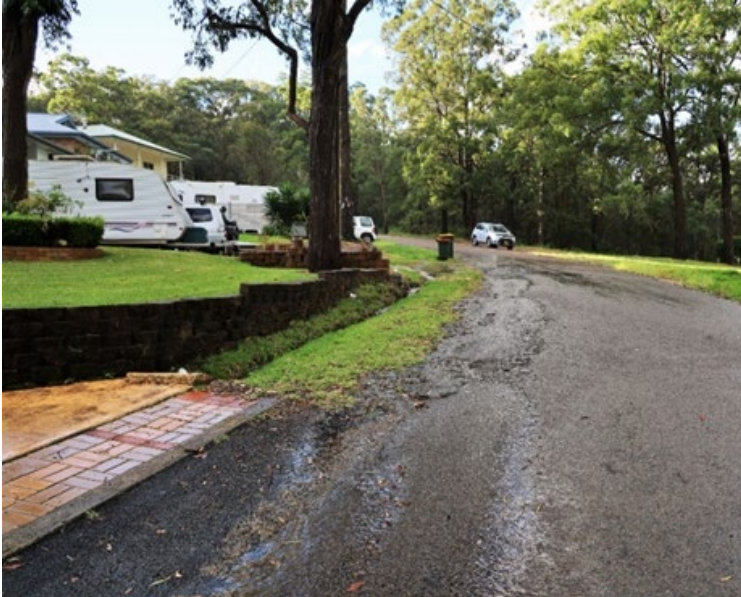
91b..		<p><u>7 Merriwa Blvd.</u> View north uphill.</p>

<p>Table Drain and Driveway Culvert Pipe pass some stormwater effectively downhill from this point.        The lack of drains and under driveway pipes uphill however also sends a parallel water flow down and across the road and then to downslope properties opposite.</p>	A		
-------	--	---	--	---	--	--

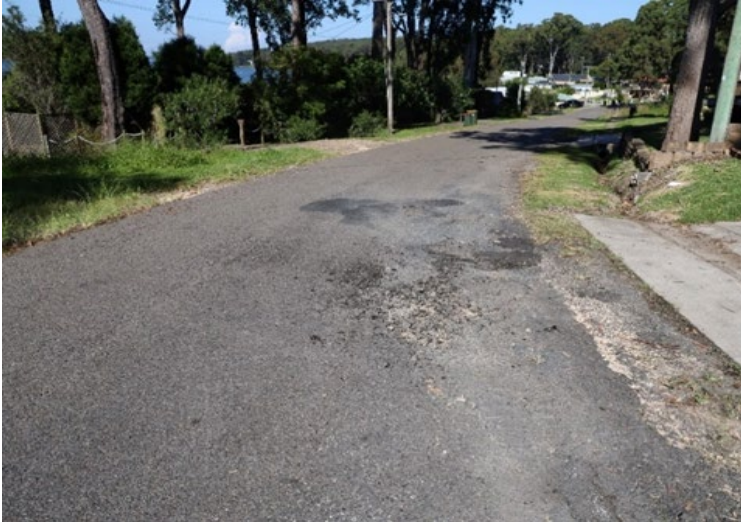
91c.		<p>5 Merriwa Blvd. View south downhill.</p>

<p>Road surface repaired previously showing subsequent and continuing damage in two places from heavy Cross Road Flooding from two Dish Driveways opposite.</p>	A		
------	--	--	---	---	--	--

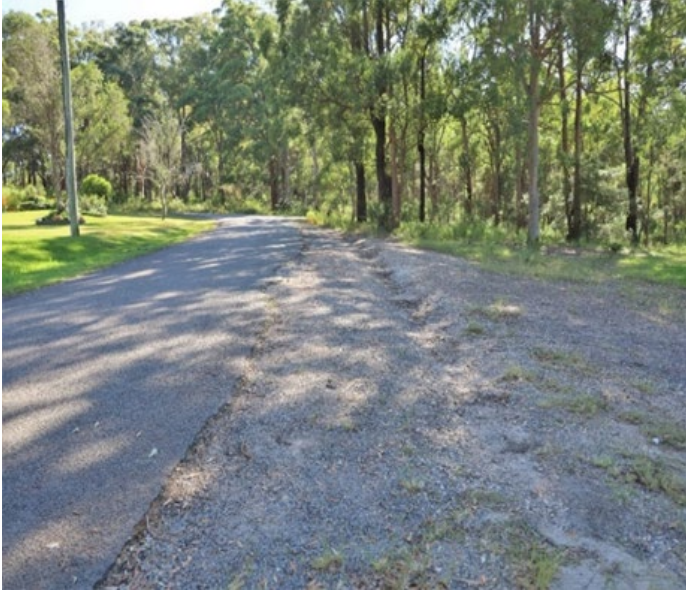
91d.		<p>4 Merriwa Blvd. View north</p>

<p>East side of road showing edge erosion and shallow depth of drain. These, with slope and lack of vegetation, creates increased flow velocity to properties adjacent and further downhill. Taken 65 metres. from Gloucester St. intersection.</p>			
------	--	--	---	--	--	--

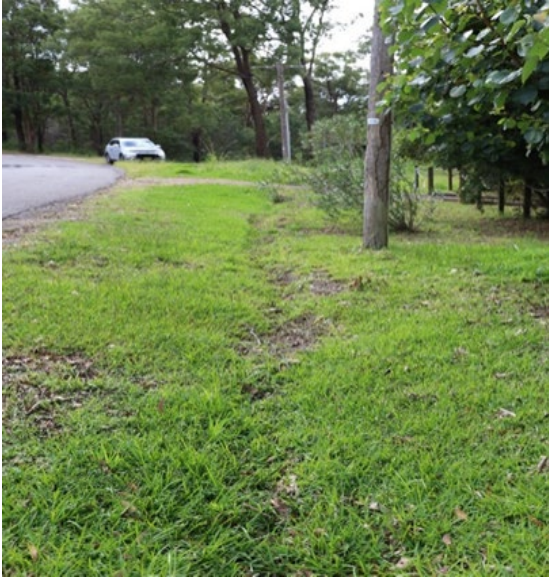
91e.		<p>8 Merriwa Blvd. View north.</p>

<p>Shallow and poorly defined drain inadequate to control water volumes flowing from upslope and down-hill from Gloucester St.</p>			
------	--	--	--	--	--	--

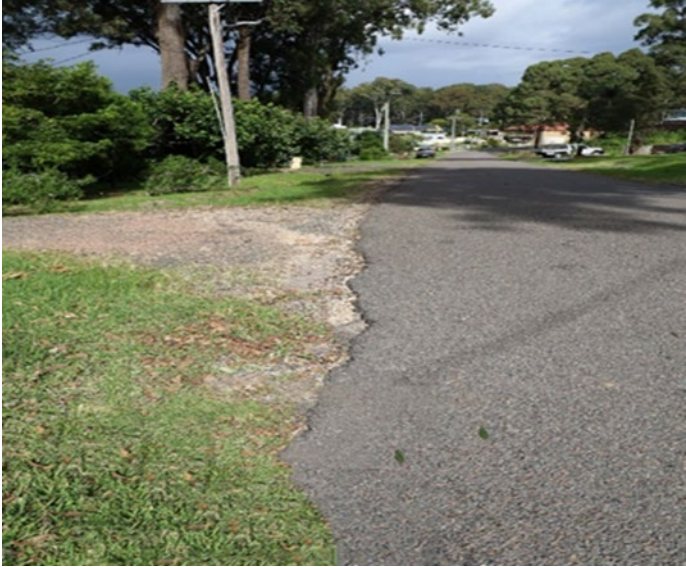
91f.		8 Merriwa Blvd .View south.

Edge erosion from Cross Road Flooding.			
------	--	---	--	--	--	--

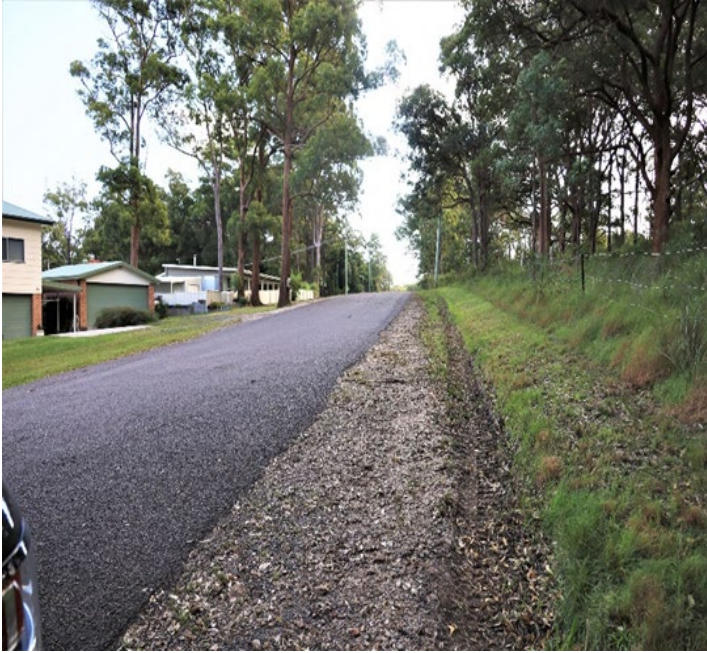
<p>91g. New</p>		<p>Corner Gloucester St. and Merriwa Blvd.. View South.</p>

<p>Advice from long term residents is that the Surface flooding into Merriwa Blvd. is primarily coming from this area along Gloucester St. and land north and west of this intersection. Someone has recently driven the tyres of a heavy vehicle along the verge where a good size Table Drain should be. This slight indentation would have little impact on the directional control of surface flooding during heavy rains.</p> <p>Council cleared and increased the Drain depth in 2023 which reduced the Cross Road Flow into Merriwa Blvd. however the Drain area closer to the Eastslope Way intersection requires further deepening to reduce Cross Road Flows to properties opposite and hence down to Merriwa Blvd.</p>	<p>A</p>		
---------------------	--	--	---	----------	--	--

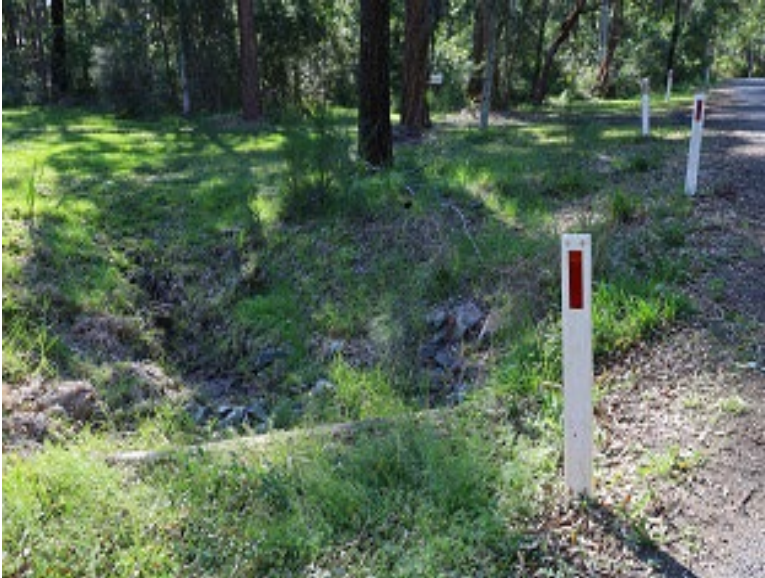
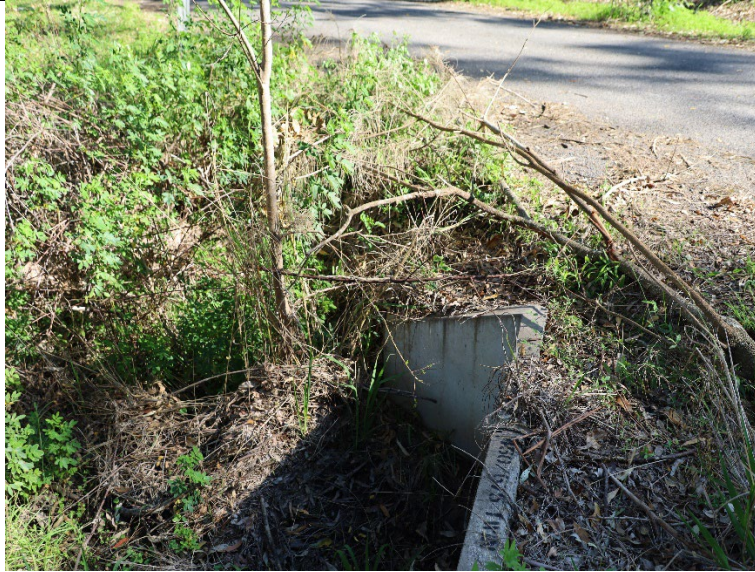
<p>92 New</p>		<p>53 The Esplanade North Side Drain Inlet Pit.</p>

<p>South Side of Road Drain Outlet</p>	<p>Deep Pit for heavy Stormwater inlet flow on north side of road and deep Drain outlet on south side opposite. No adequate protection for vehicles or pedestrians, especially children from accidentally entering or falling in. One person has fallen into the Drain Outlet after stepping from a vehicle. Vehicle Safety Railing should be installed for both sides of road above the Pit and Drain.</p>	<p>A</p>		
-------------------	--	---	---	----------	--	--

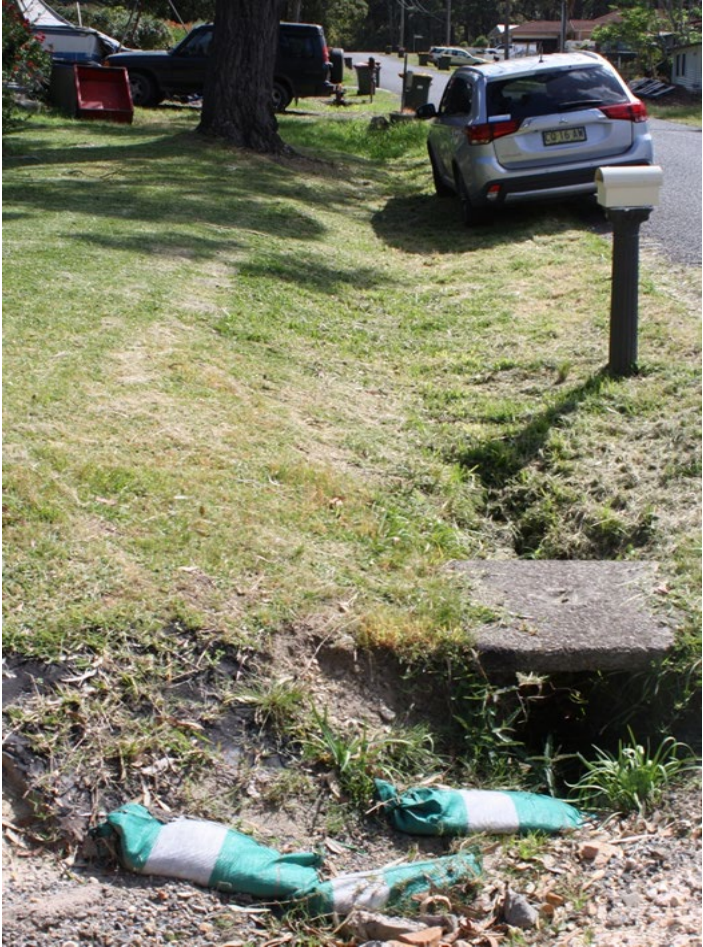
<b>Period</b>
3.	S1	<p>Reconstruct existing drainage pit north west corner <u>Merriwa Blvd / Eastslope Way.</u></p>

<p>Pit has not been upgraded to mesh type and fails child safety requirements.</p> <p>Higher volumes of water being directed to it than its design can cope with and sandbags end up further reducing water volumes due to movement to drain.</p> <p>Pit discharges to north east corner via under road culvert which is undersized for the volumes directed to it. Hazardous vehicle, pedestrian situation with open drain. Refer Ref. No.89.</p> <p>Cross road overflows from this Drain consistently damage adjacent road surfaces.</p>	A	1 & 2

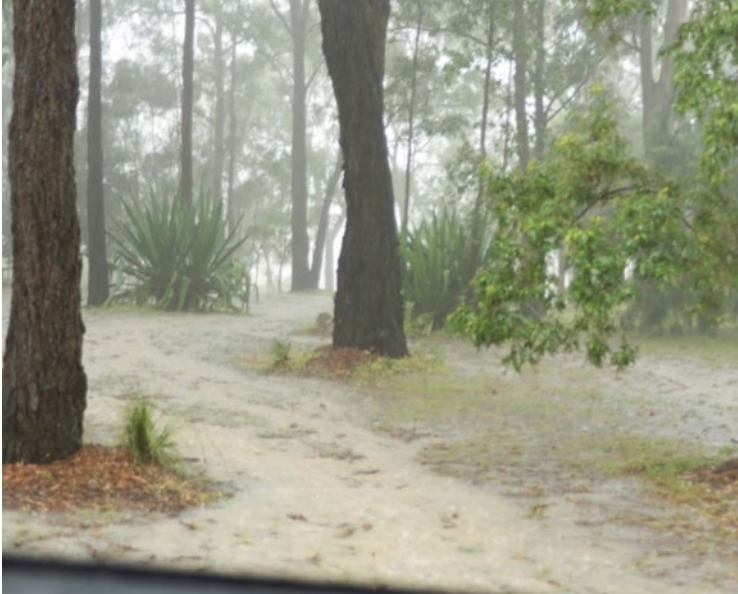
<p>8 cont.</p>	<p>S1</p>	<p><u>Casuarina Park</u></p>

<p>Thus, two significant problems, uncontrolled erosion of the park and inability to lengthen the Ramp to a practical and useful length would be resolved. Most importantly, the current very unsafe construction of the Ramp end would be eliminated.</p> <p>All existing Concrete pits feeding to the two main pipes including adjacent to house Nos 57, 61 and 63 should be converted to mesh style to reduce the impact of debris build-up and subsequent flow restriction.</p> <p>Currently sandbagged which ultimately further reduces the pits effectiveness.</p> <p>Heavy cross road flow into Casuarina as a consequence. Sealing of the track to the Ramp recently by Council has reduced the erosion flow and provided safer access. It will be interesting to record flows when the next heavy sustained rain event occurs.</p>			
--------------------	-----------	---	---	--	--	--

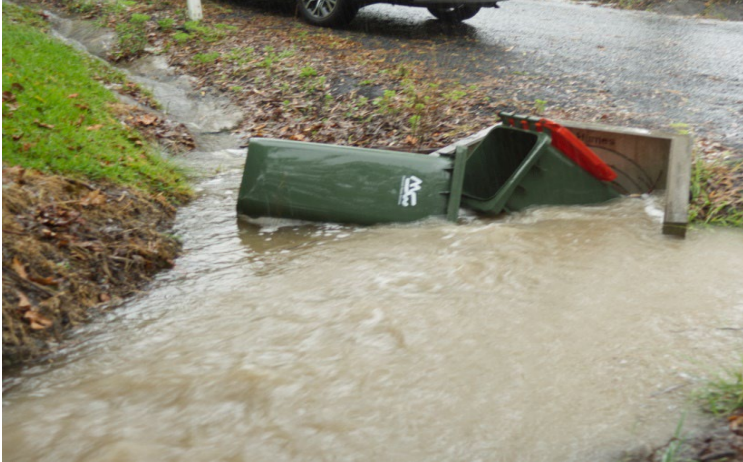
15	S2b	<p>Construct new debris barriers <u>Water St.</u></p>

<p>PARTLY COMPLETED north side of drain only but not well maintained.</p> <p>This south side of under road inlet also requires debris barriers and child access protection.</p>	A		
----	-----	--	---	---	--	--

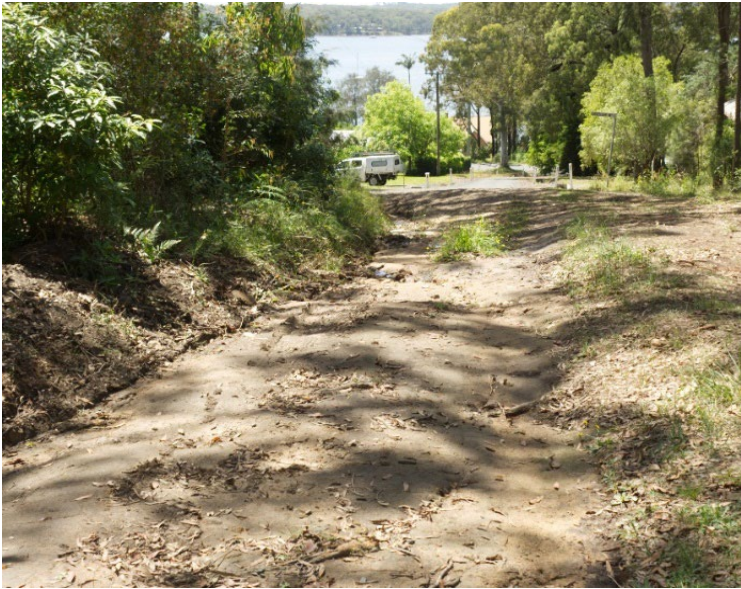
19	S2b	<p>Regrade &amp; seal track between corner <u>Eastslope Way and Water St.</u> and Yallahah Park, east side car parking area.</p>

<p>NOT DONE. This is the top end of Water St. <u>Suggest regrade and bitumen seal.</u> Construct drains on both sides with sediment and debris diversion / barriers.</p> <p>Currently vehicle access to the Park and rear of properties from here is blocked to vehicles by boulders. These should be removed now to allow access to convenient parking adjacent to the Exercise Track and clear access for Fire Tenders.</p> <p>and Crews to this area.</p>	A+	2	
----	-----	---	--	----	---	--

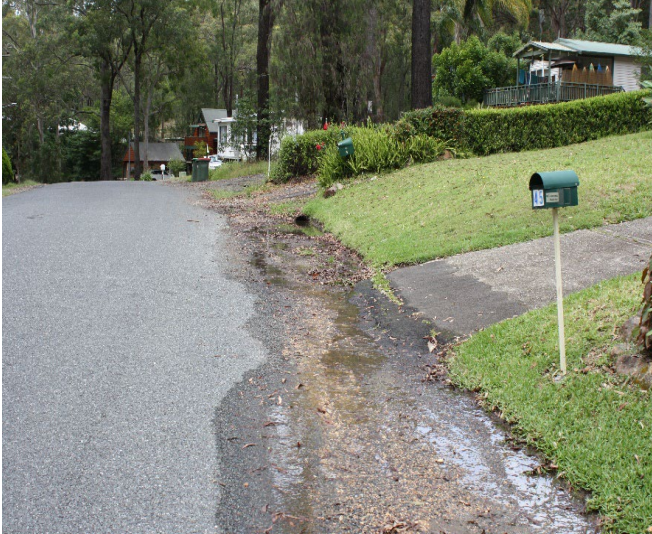
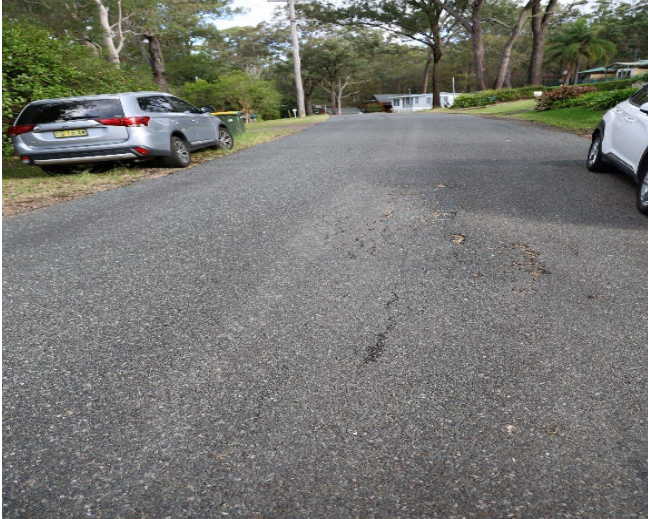
20	S2c	Construct sub-soil drainage system. <u>43 - 49 Cove Blvd.</u>

NOT DONE.	A	2	
----	-----	--	-----------	---	---	--

<p>Taken during 2024 review. Road surface damage due to heavy Cross Road flooding since 2023 Review. Previous patching evident.</p>			
--	--	---	---	--	--	--

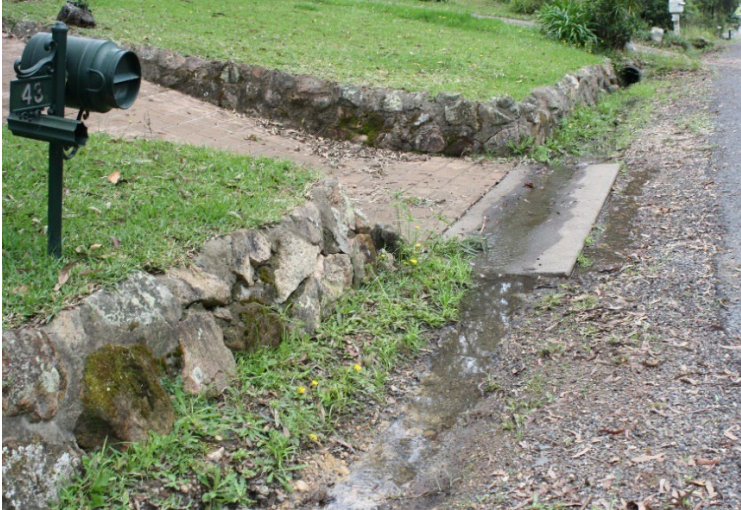
21	S2c	Construct Table Drain and Culvert Pipe Driveway crossings 43-49.	NOT DONE.	B/C	2	
22	S2c	<p>Re-construct driveway crossings. <u>43 - 49 Cove Blvd.</u></p>

NOT DONE. Currently 49 has no culvert driveway pipe. Flows from driveway across road with consequent road surface damage.	A	2

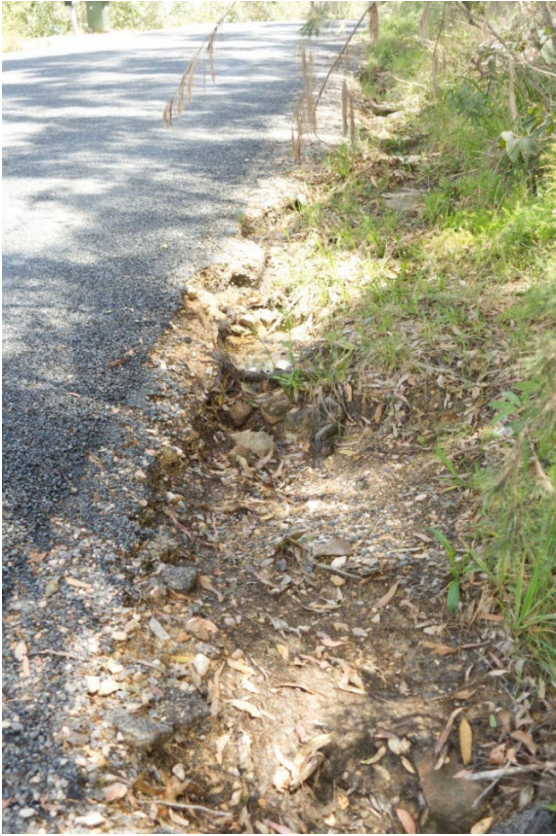
68	Fig 4-	Table Drain <u>99 - 107 Cove Blvd.</u>	Drain has eroded to edge of road bitumen.			
New	5

Requires realigning to the west to create a safe verge width.	A		
			May require rock/boulder cutting.			
			Dangerous due to narrow road width.

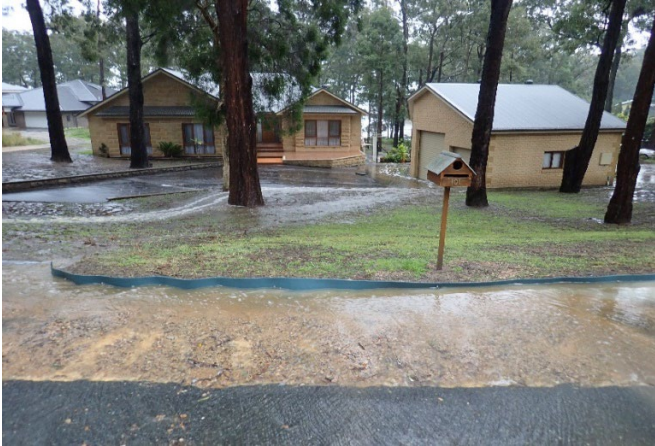
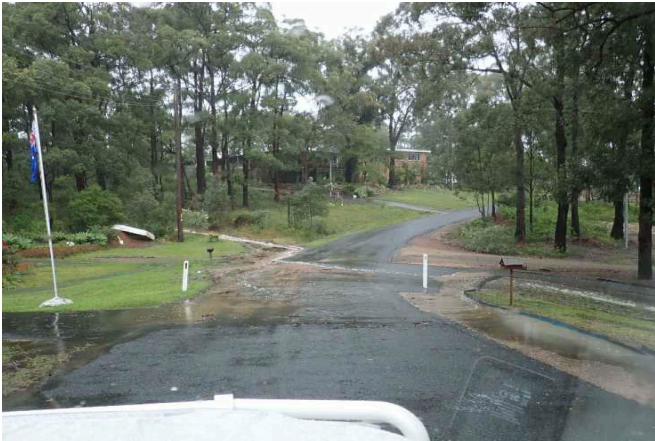
<p>85 New</p>	<p>Fig 4-8 Add</p>	<p>46 - 54 Promontory Way. No table drains or of inadequate depth to handle flow volumes.</p>

<p>Area of heavy cross road flooding. Construct table drains of consistent and adequate depth. Short drain between Nos.50 - 52 but pipe openings partly blocked. No.54 needs Council works to construct a deep drain to connect with the pit in No.52.</p> <p>Suggest problem in this area should be assessed by Engineer due to complex in flows including from Outlook Drive and flooding across road into Heros via access track and into No.101.</p>	<p>A/B</p>	<p>2</p>	
-------------------	------------------------	--	--	------------	----------	--

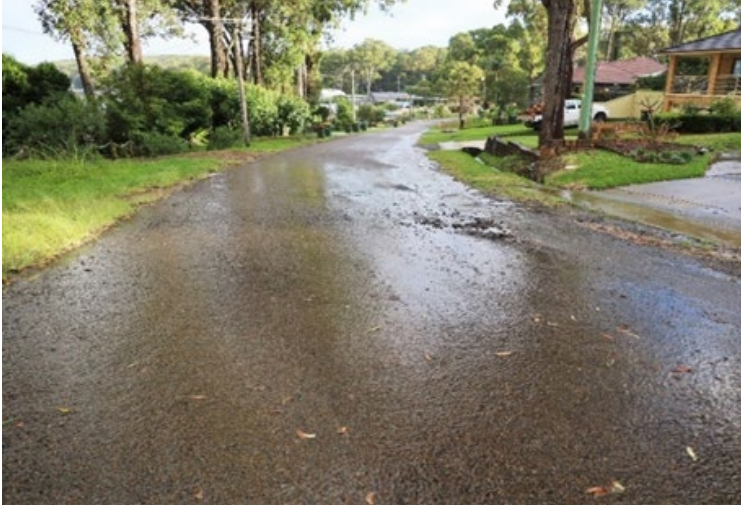
91a.	No BMT  Report for this  North end of  NAC.	<p><u>5 Merriwa Blvd.</u> View south.</p>

<p>This area in the northern end of North Arm Cove was not reported as having flooding/drainage problems in the 2014 BMT Report.</p> <p>The NACCAI Stormwater and Drainage Sub Committee became aware when contacted by a resident after the draft report was placed on our web site for resident information and comment.</p> <p>Cross road flooding occurs mostly from Gloucester St. down and impacts as far as No.12.</p>	A		
------	---	--	---	---	--	--

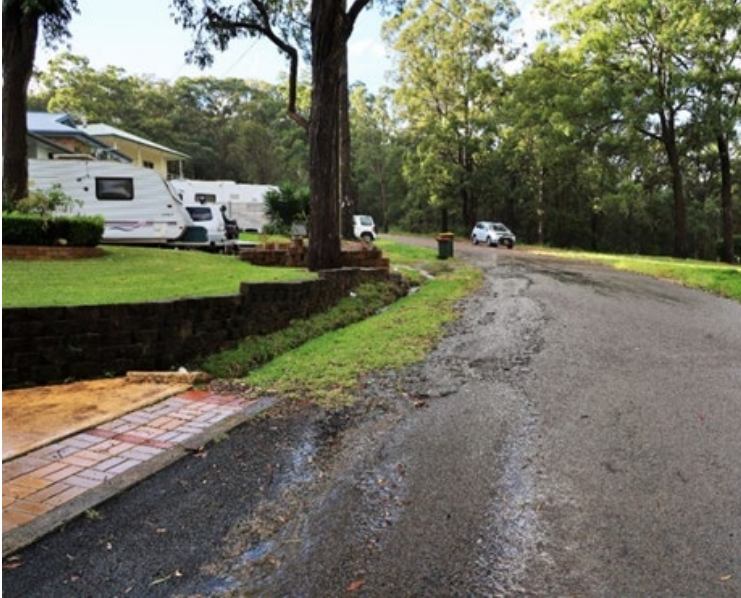
91b..		<p><u>7 Merriwa Blvd.</u> View north uphill.</p>

<p>Table Drain and Driveway Culvert Pipe pass some stormwater effectively downhill from this point.</p> <p>The lack of drains and under driveway pipes uphill however also sends a parallel water flow down and across the road and then to downslope properties opposite.</p>	A		
-------	--	---	--	---	--	--

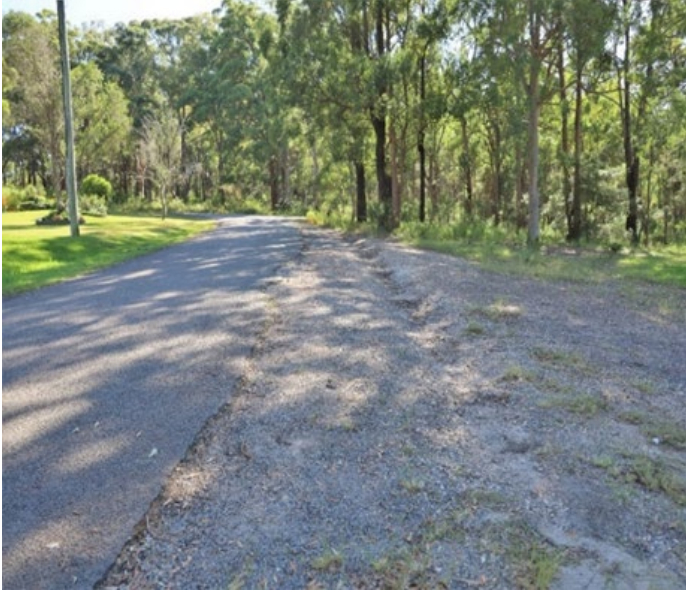
91d.		<p>4 Merriwa Blvd. View north</p>

<p>East side of road showing edge erosion and shallow depth of drain. These, with slope and lack of vegetation, creates increased flow velocity to properties adjacent and further downhill. Taken 65 metres. from Gloucester St. intersection.</p>			
------	--	--	---	--	--	--

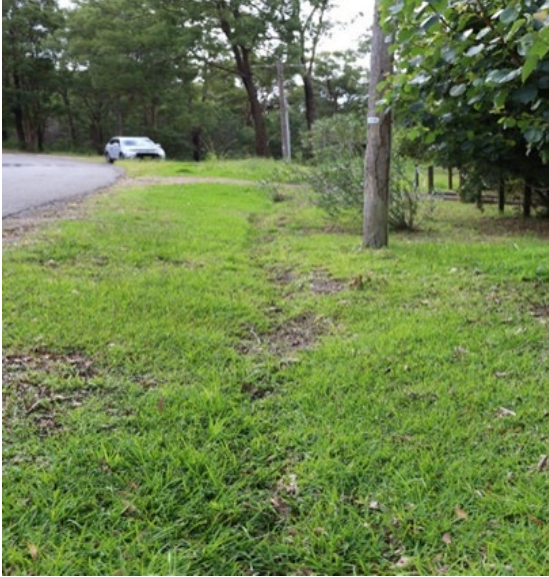
91e.		<p>8 Merriwa Blvd. View north.</p>

<p>Shallow and poorly defined drain inadequate to control water volumes flowing from upslope and down-hill from Gloucester St.</p>			
------	--	--	--	--	--	--

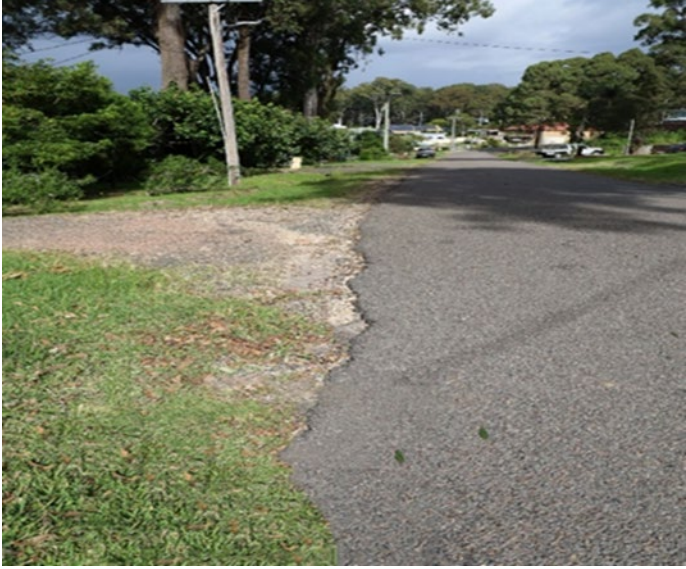
91f.		<p>8 Merriwa Blvd .View south.</p>

<p>Edge erosion from Cross Road Flooding.</p>			
------	--	---	---	--	--	--

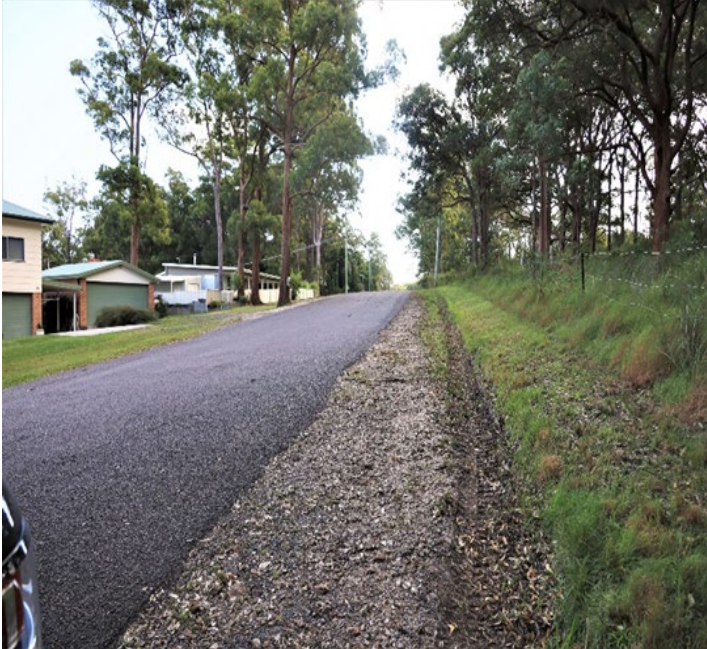
<p>91g. New</p>		<p>Corner Gloucester St. and Merriwa Blvd.. View South.</p>

<p>Advice from long term residents is that the Surface flooding into Merriwa Blvd. is primarily coming from this area along Gloucester St. and land north and west of this intersection.</p> <p>Someone has recently driven the tyres of a heavy vehicle along the verge where a good size Table Drain should be. This slight indentation would have little impact on the directional control of surface flooding during heavy rains.</p> <p>Council cleared and increased the Drain depth in 2023 which reduced the Cross Road Flow into Merriwa Blvd. however the Drain area closer to the Eastslope Way intersection requires further deepening to reduce Cross Road Flows to properties opposite and hence down to Merriwa Blvd.</p>	<p>A</p>		
---------------------	--	--	--	----------	--	--

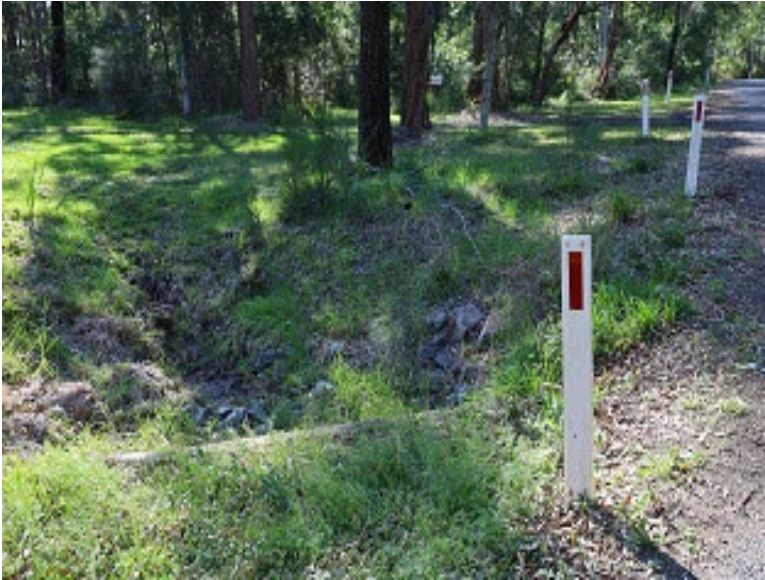
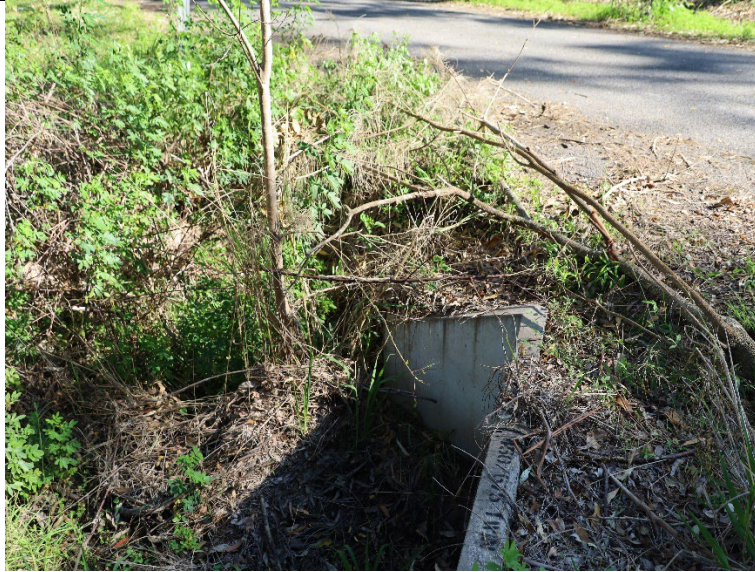
<p>92 New</p>		<p>53 The Esplanade North Side Drain Inlet Pit.</p>

<p>South Side of Road Drain Outlet</p>	<p>Deep Pit for heavy Stormwater inlet flow on north side of road and deep Drain outlet on south side opposite. No adequate protection for vehicles or pedestrians, especially children from accidentally entering or falling in.</p> <p>One person has fallen into the Drain Outlet after stepping from a vehicle.</p> <p>Vehicle Safety Railing should be installed for both sides of road above the Pit and Drain.</p>	<p>A</p>		
-------------------	--	---	---	----------	--	--
