NACCAI Stormwater Management Action Report to Mid Coast Council. Review 2 *24 Feb. 2022.

A report by the Residents Association's Roads, Drainage and Signage Sub Committee on the status of progress in completing works identified in the BMT North Arm Cove Stormwater Management Strategy Report to Council (2017), following inspections by Seamus Devlin and Gary Sylvaney during October/November 2020. For a description of priority and work level required classifications, see table on last page. It is not intended to include works requests in this report that would be considered normal periodic maintenance by the local Council Depot, for example Table Drain clearing. This Report seeks to identify for Council works planning/budgeting Stormwater/Drainage issues in North Arm Cove that create damage to residential properties, council assets, topography and/or safety hazards.

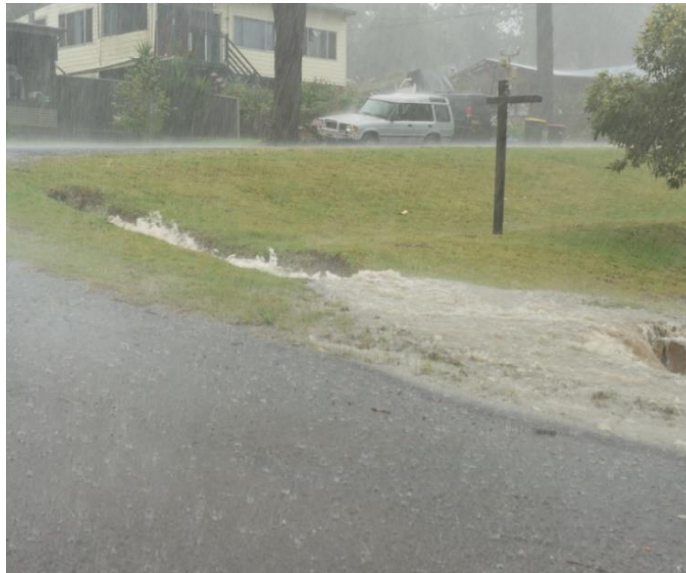
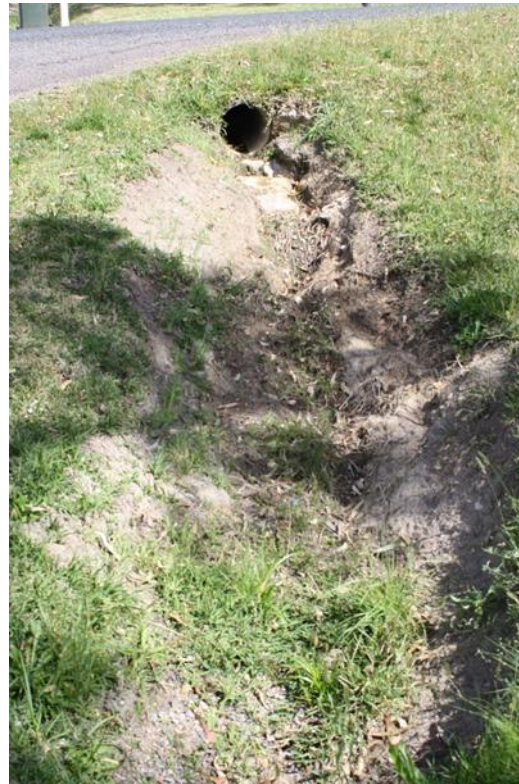
<p>90 New</p>	<p>Fig S3c</p>	<p>106 Cove Blvd. (Photo taken from 108).</p>

<p>Result of Cross Road Flooding. from uphill/upslope into Nos.104 to 106.</p> <p>104 Cove Blvd. was identified for remedial works in the 2014 BMT Report. (Refer Ref. Nos. 29-38).</p> <p>Whilst some Pit and easement work was completed just south of this location, it did not improve the Cross Road Flooding for this property.</p> <p>As recommended an additional collection pit and easement should solve the problem. The upslope flooding into this area is too excessive for existing deep Table Drains and existing Pit to cope.</p>	<p>A</p>	<p>3</p>	
-------------------	--------------------	---	---	----------	----------	--
