NACCAI Stormwater Management Action Report to Mid Coast Council. Review 3.1 9 Feb. 2023.

A report by the Residents Association's Roads, Drainage and Signage Sub Committee on the status of progress in completing works identified in the BMT North Arm Cove Stormwater Management Strategy Report to Council (2017), following inspections by Seamus Devlin and Gary Sylvaney during October/November 2020. For a description of priority and work level required classifications, see table on last page. It is not intended to include works requests in this report that would be considered normal periodic maintenance by the local Council Depot, for example Table Drain clearing. This Report seeks to identify for Council works planning/budgeting Stormwater/Drainage issues in North Arm Cove that create damage to residential properties, council assets, topography and/or safety hazards.

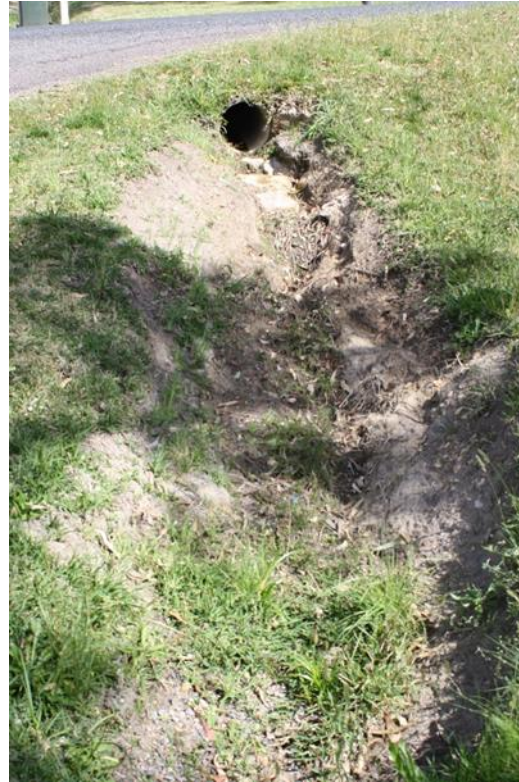
86 New	Fig 4-8	Access track to Heros Bay badly eroded on south side.	PRIORITY. Could be hazardous to vehicles and pedestrians at lower end.			
87 News	Fig 4-8	58 - 68 Promontory Way. Table drains too shallow or non-existent.	Table drains require deepening and some driveway pipes are undersize.	A/B	3	
88 New	Fig 4-8	1 - block 29 The Esplanade. (Continuation from end of Promontory Way) No table drains.	Construct Table Drains.	A/B	2	
89	Fig 4-3	38 Eastslope Way. Open drain too deep.	Construct enclosed drain from under road outlet to driveway inlet. Currently hazardous.	A/B	2
